MARIN COUNTY PARKS

MCNEARS BEACH PARK

PIER REPAIR

ISSUED FOR CONSTRUCTION

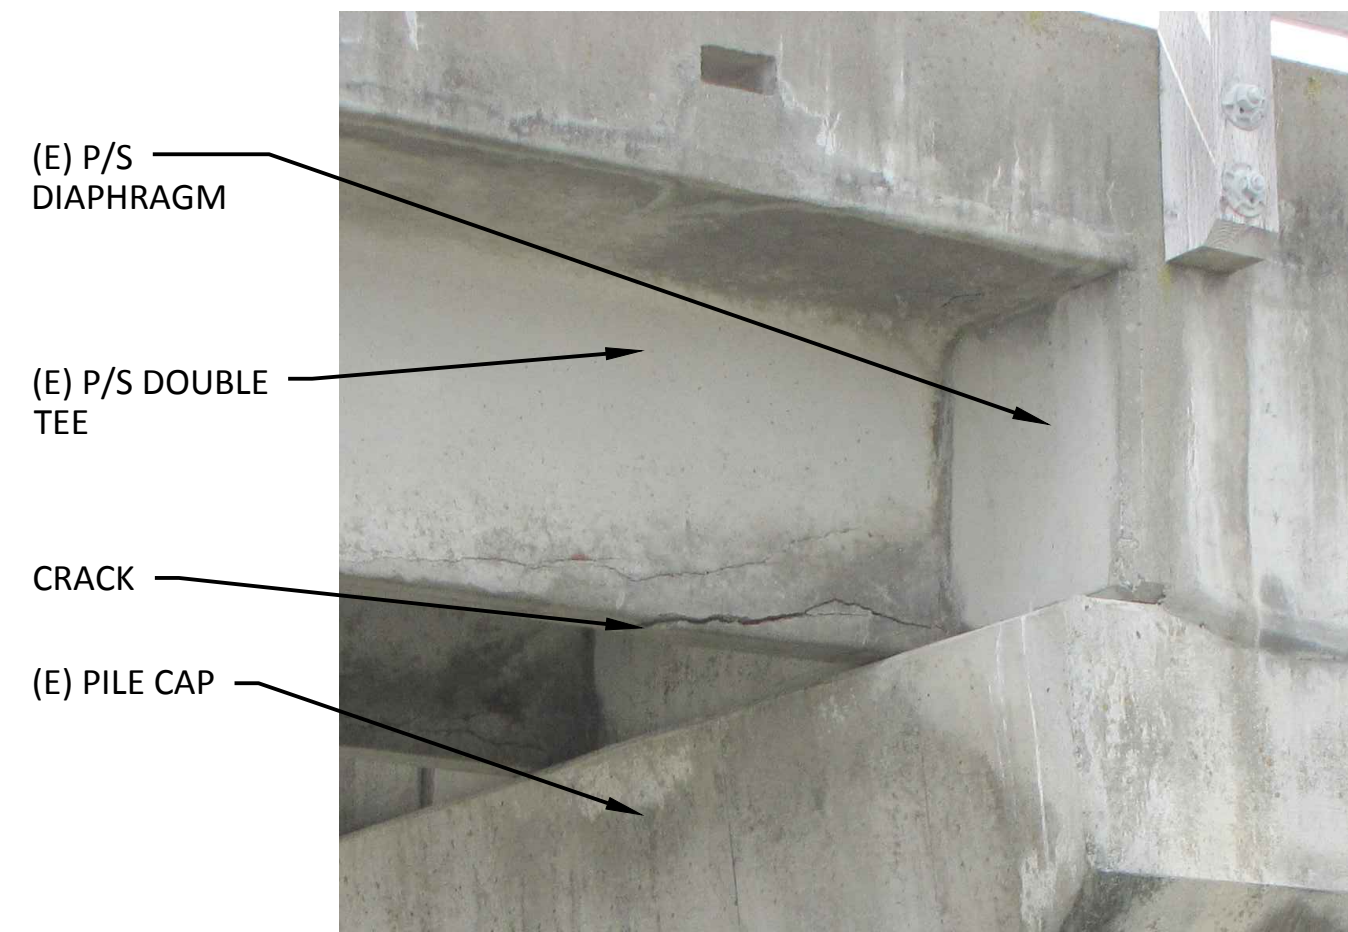
TEE CRACKING AT BOTTOM NEAR PILE CAP

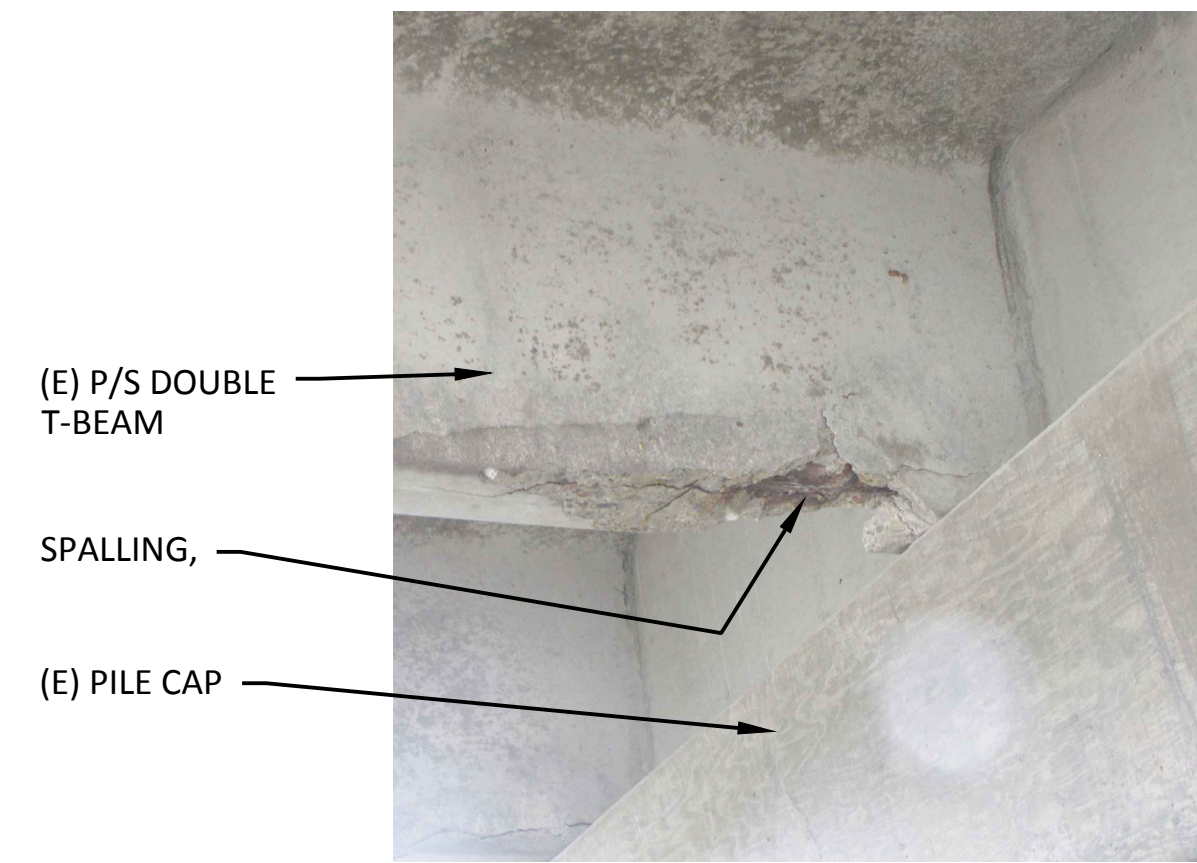
TEE SPALLING AT BOTTOM NEAR AT PILE CAP

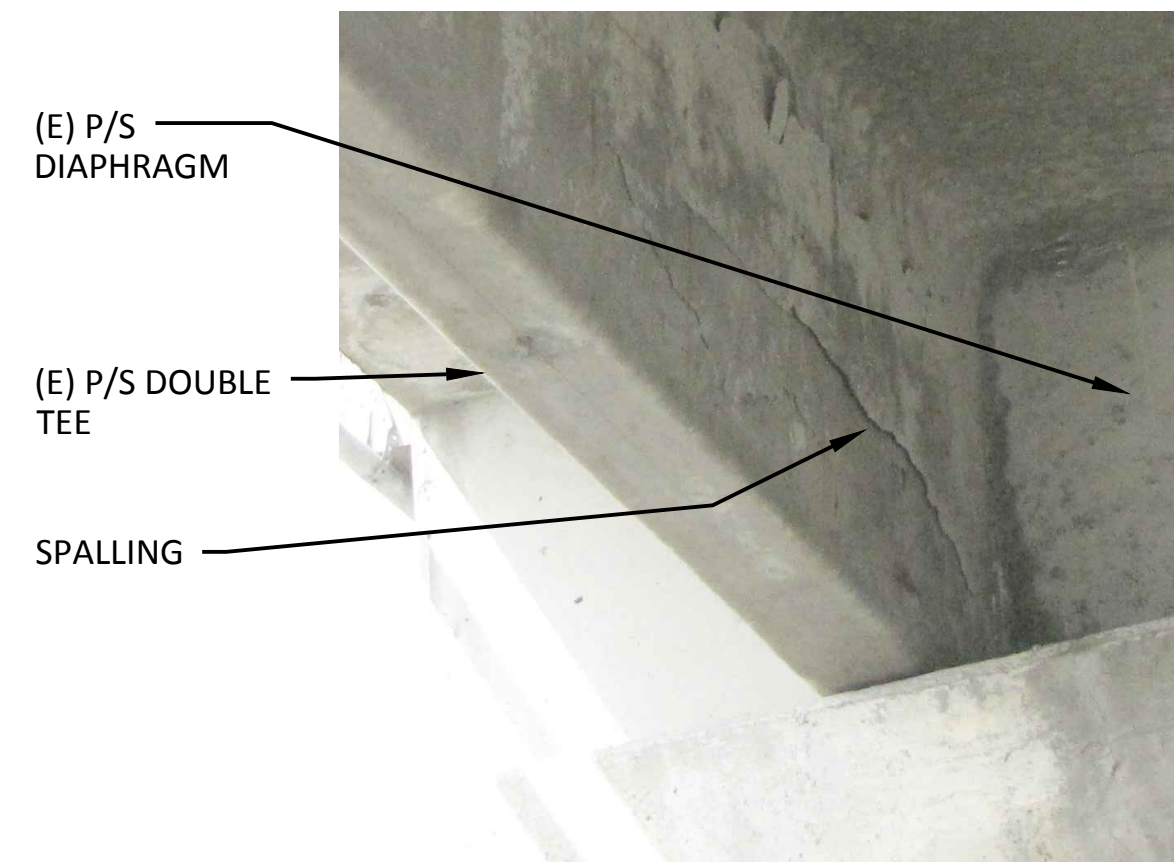
TEE WEB SPALLING NEAR PILE CAP

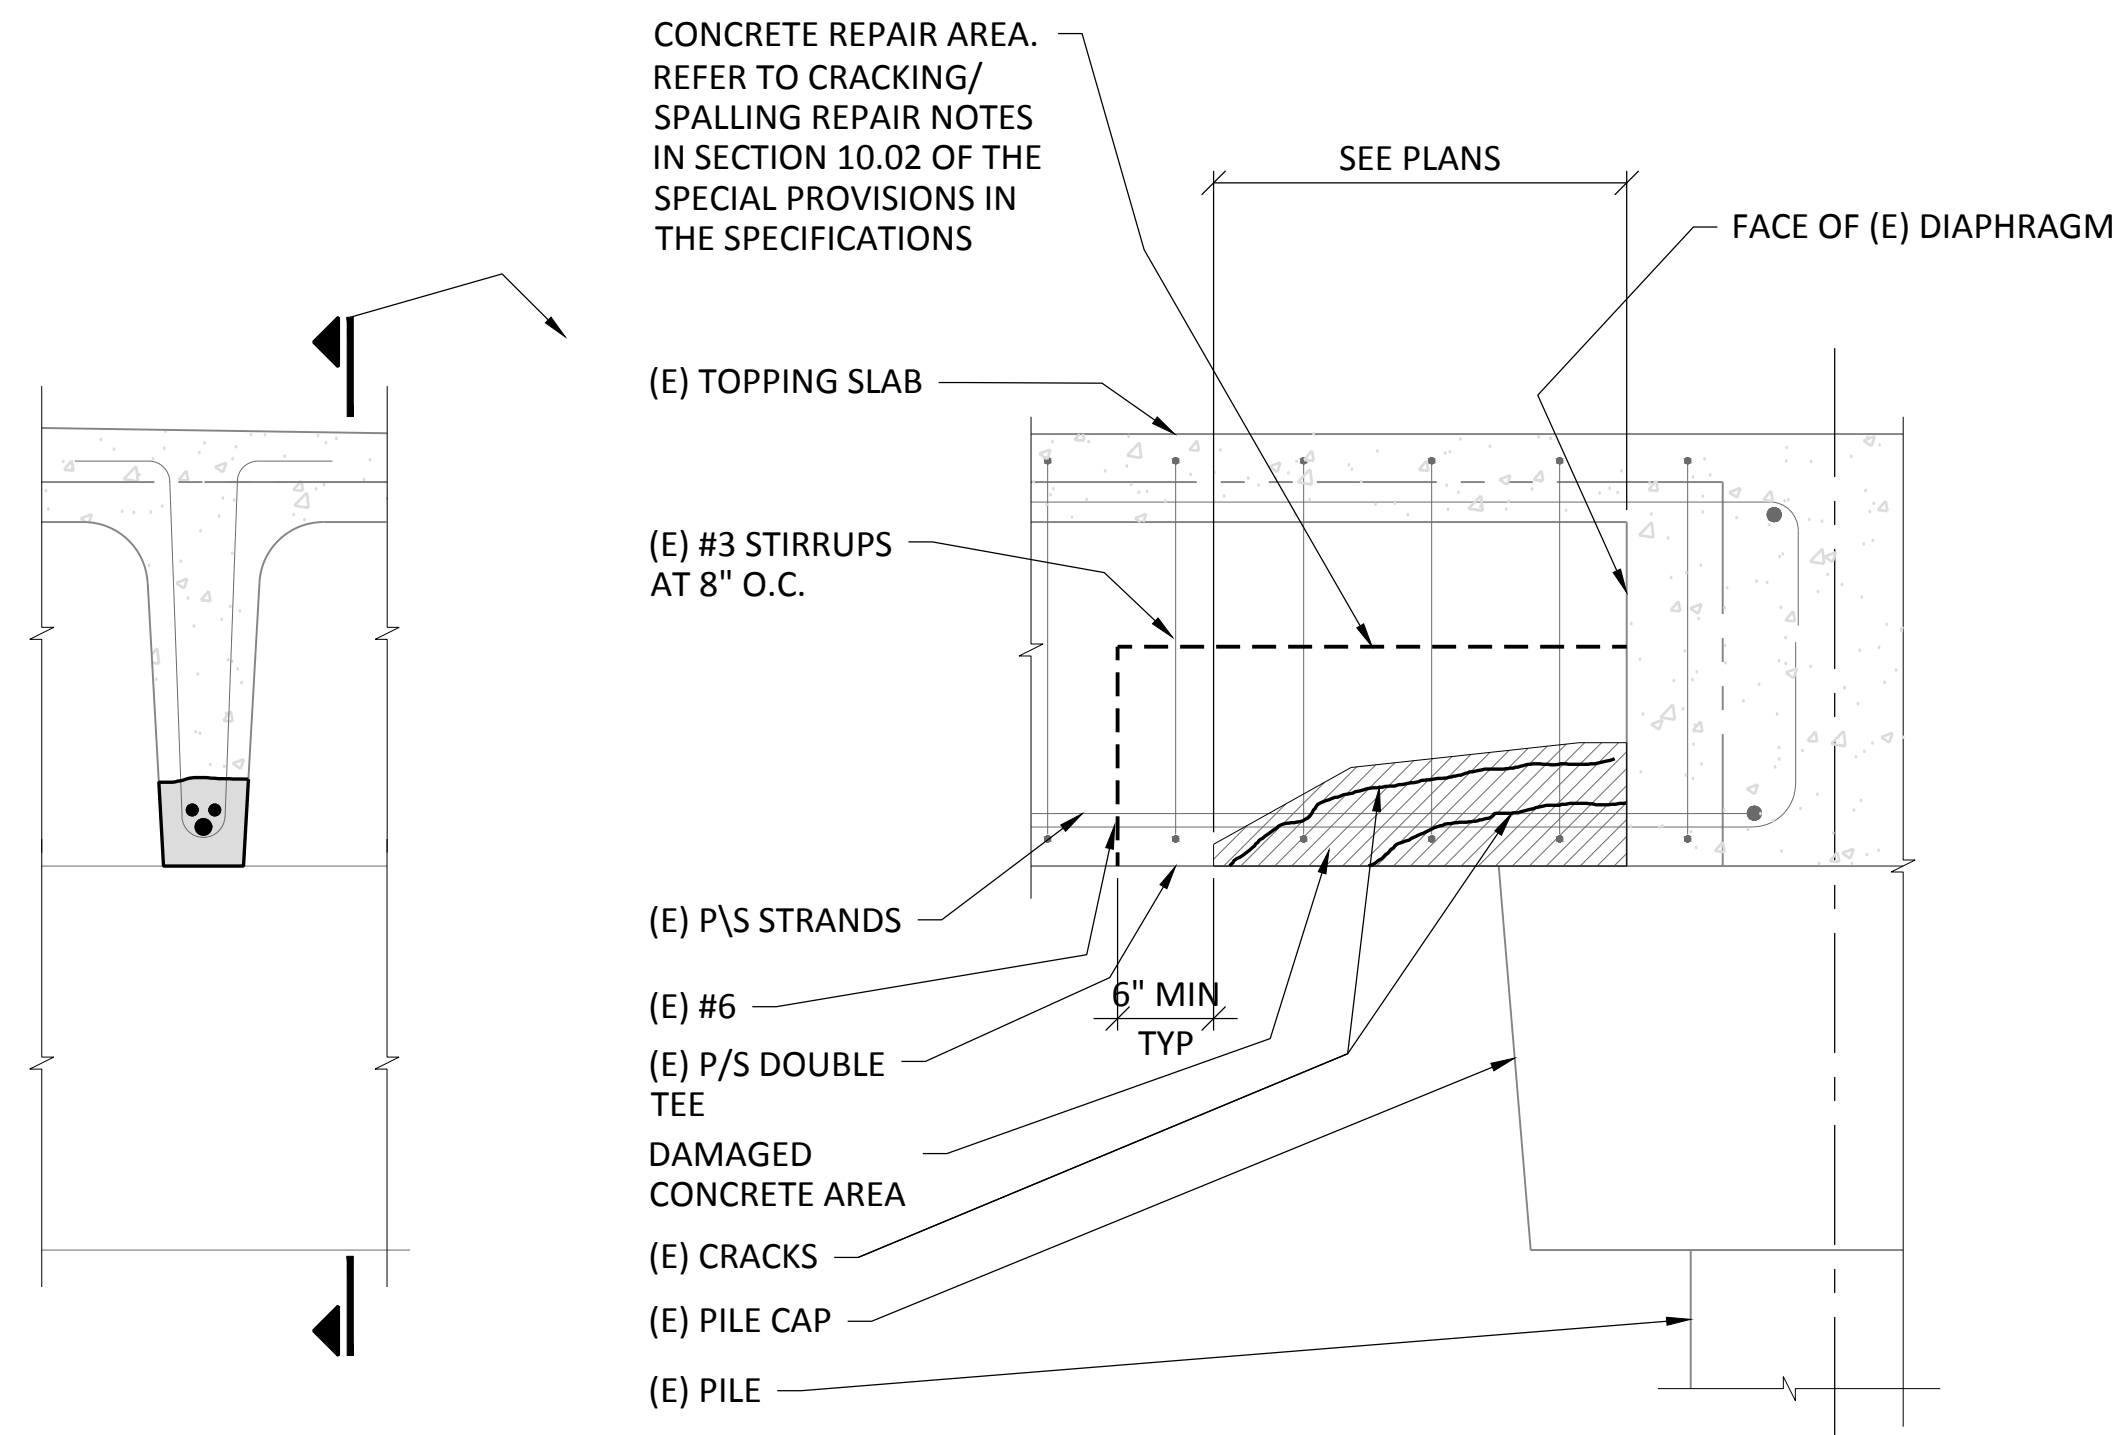
TEE REPAIR T1
1" = 1'-0"

NOTE:
DAMAGE VARIES
COULD EXTEND TO
FULL DEPTH OF WEB

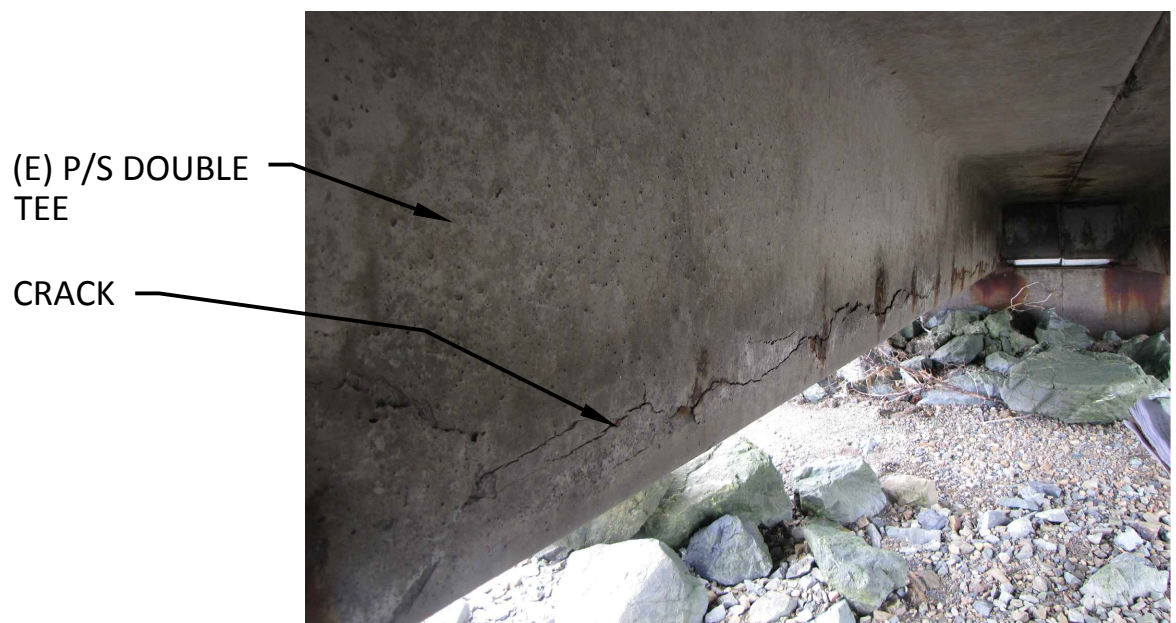
TEE CRACKING AT SPAN 1

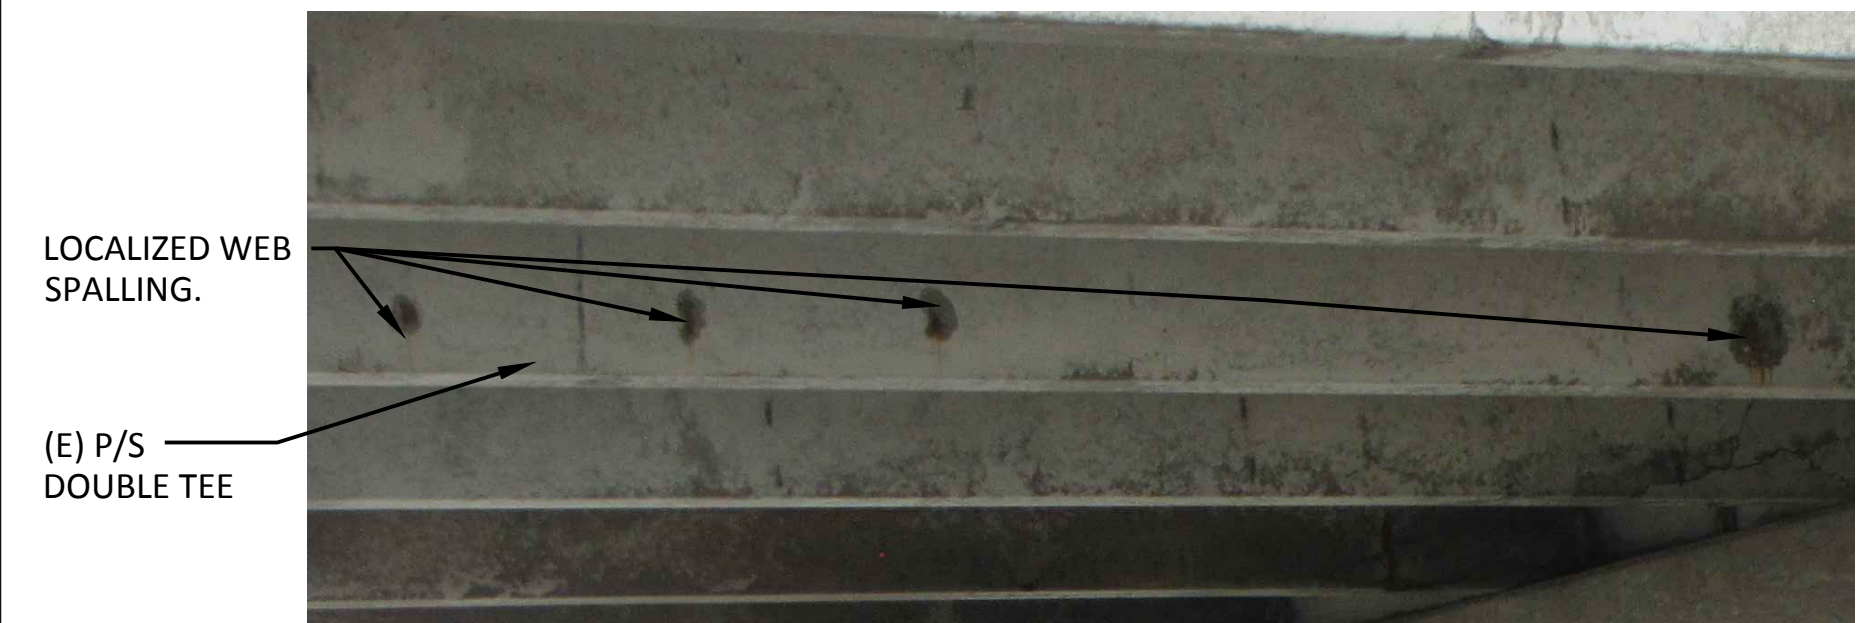
LOCALIZED TEE WEB SPALLING

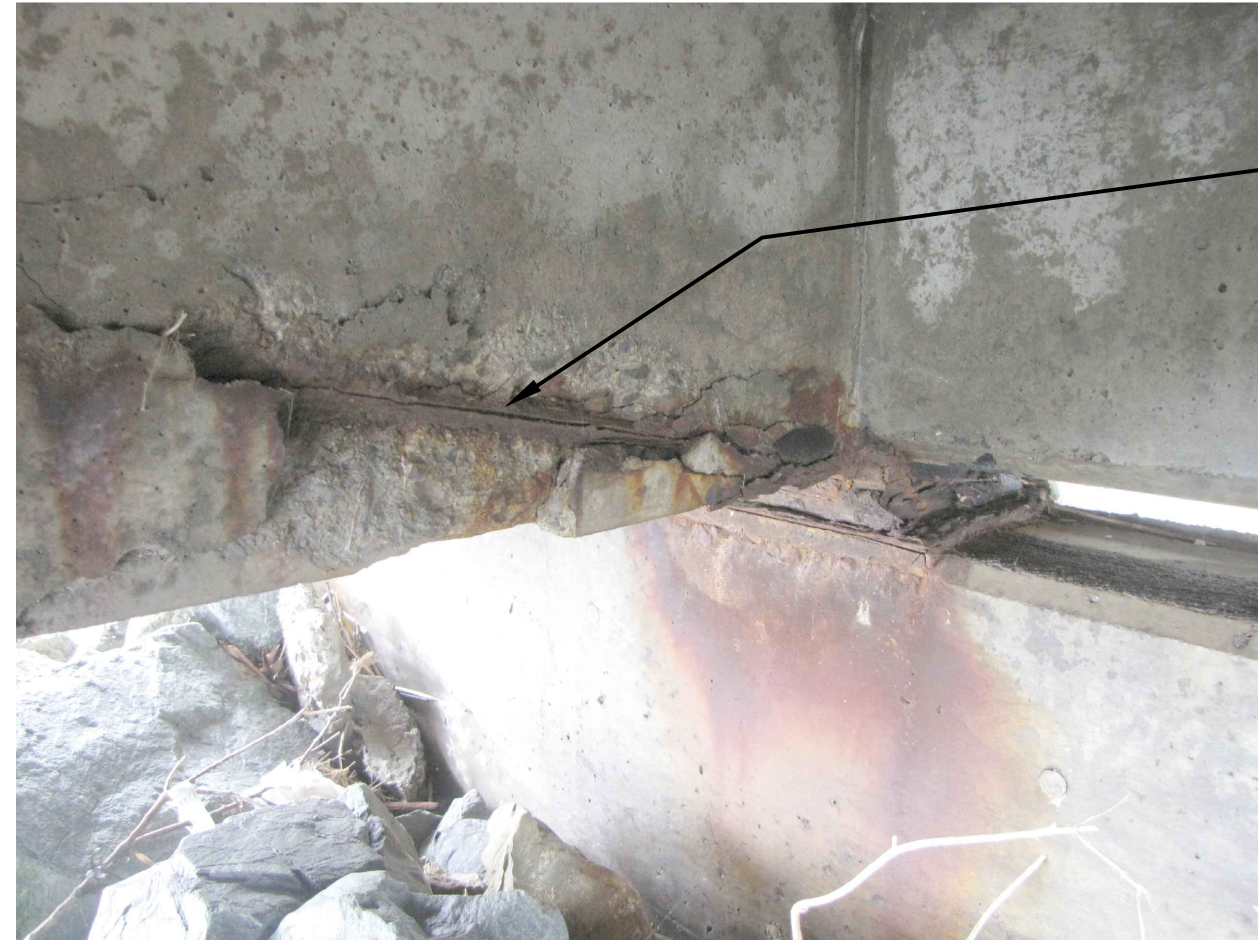
SPALLING AT SUPPORT

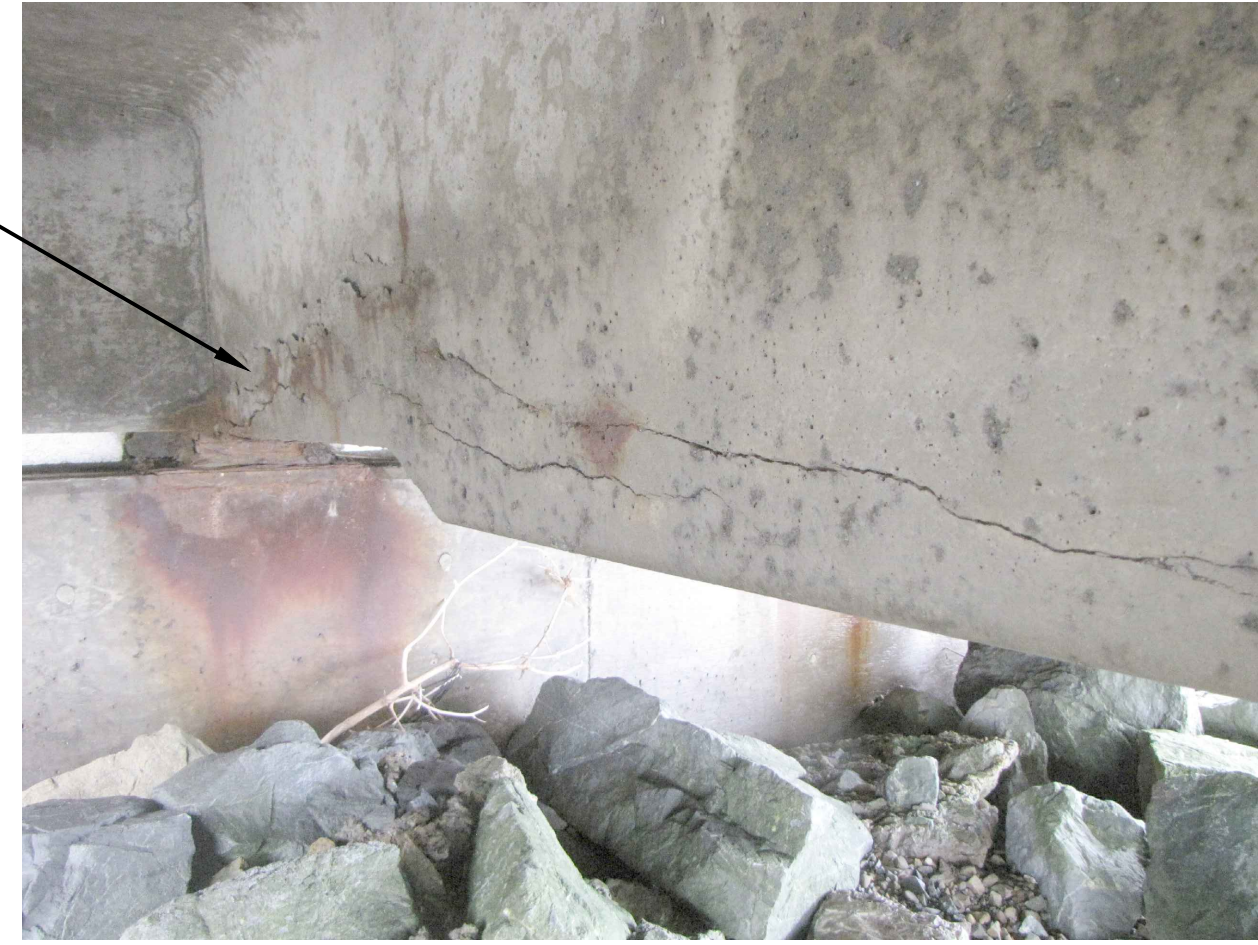
TEE SPALLING AT SPAN 1

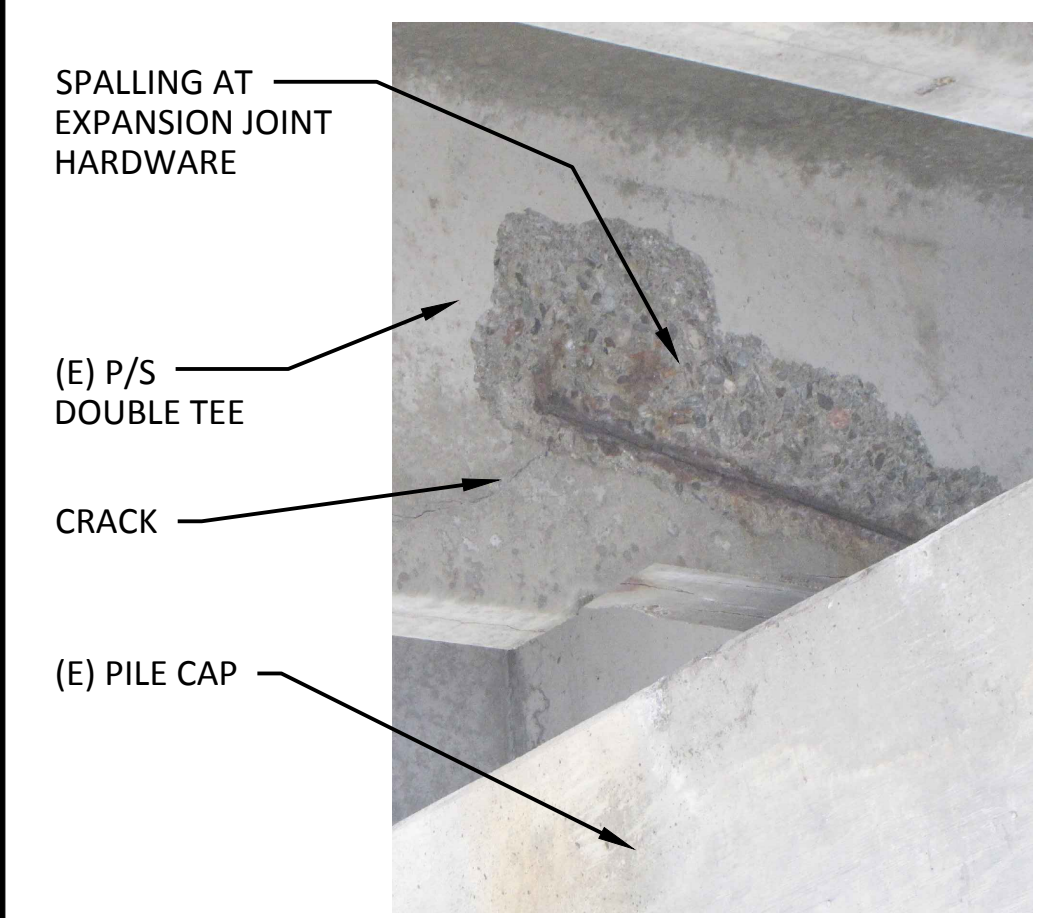
SPALLING AT EXPANSION JOINT HARDWARE
(E) P/S DOUBLE TEE
CRACK
(E) PILE CAP

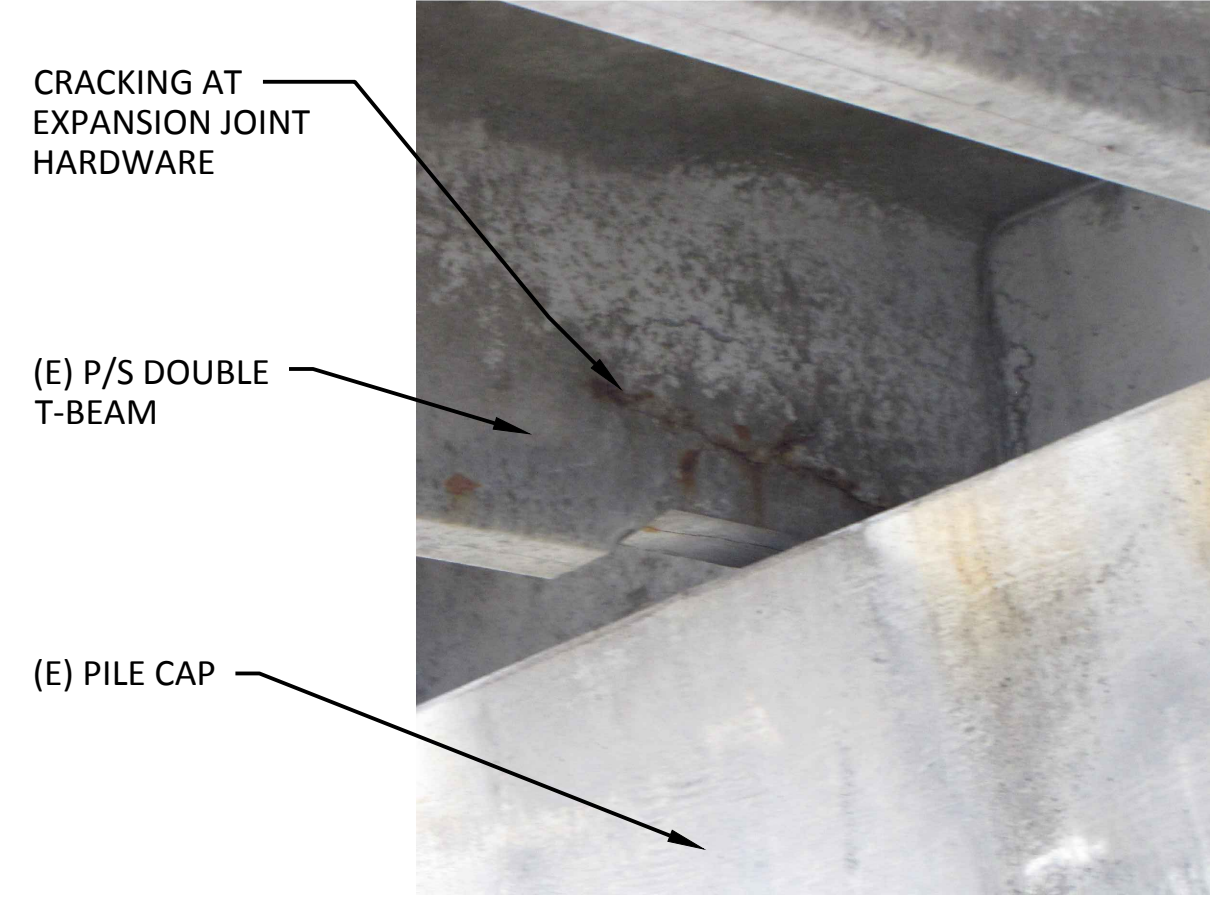
CRACKING AT EXPANSION JOINT HARDWARE
(E) P/S DOUBLE T-BEAM
(E) PILE CAP

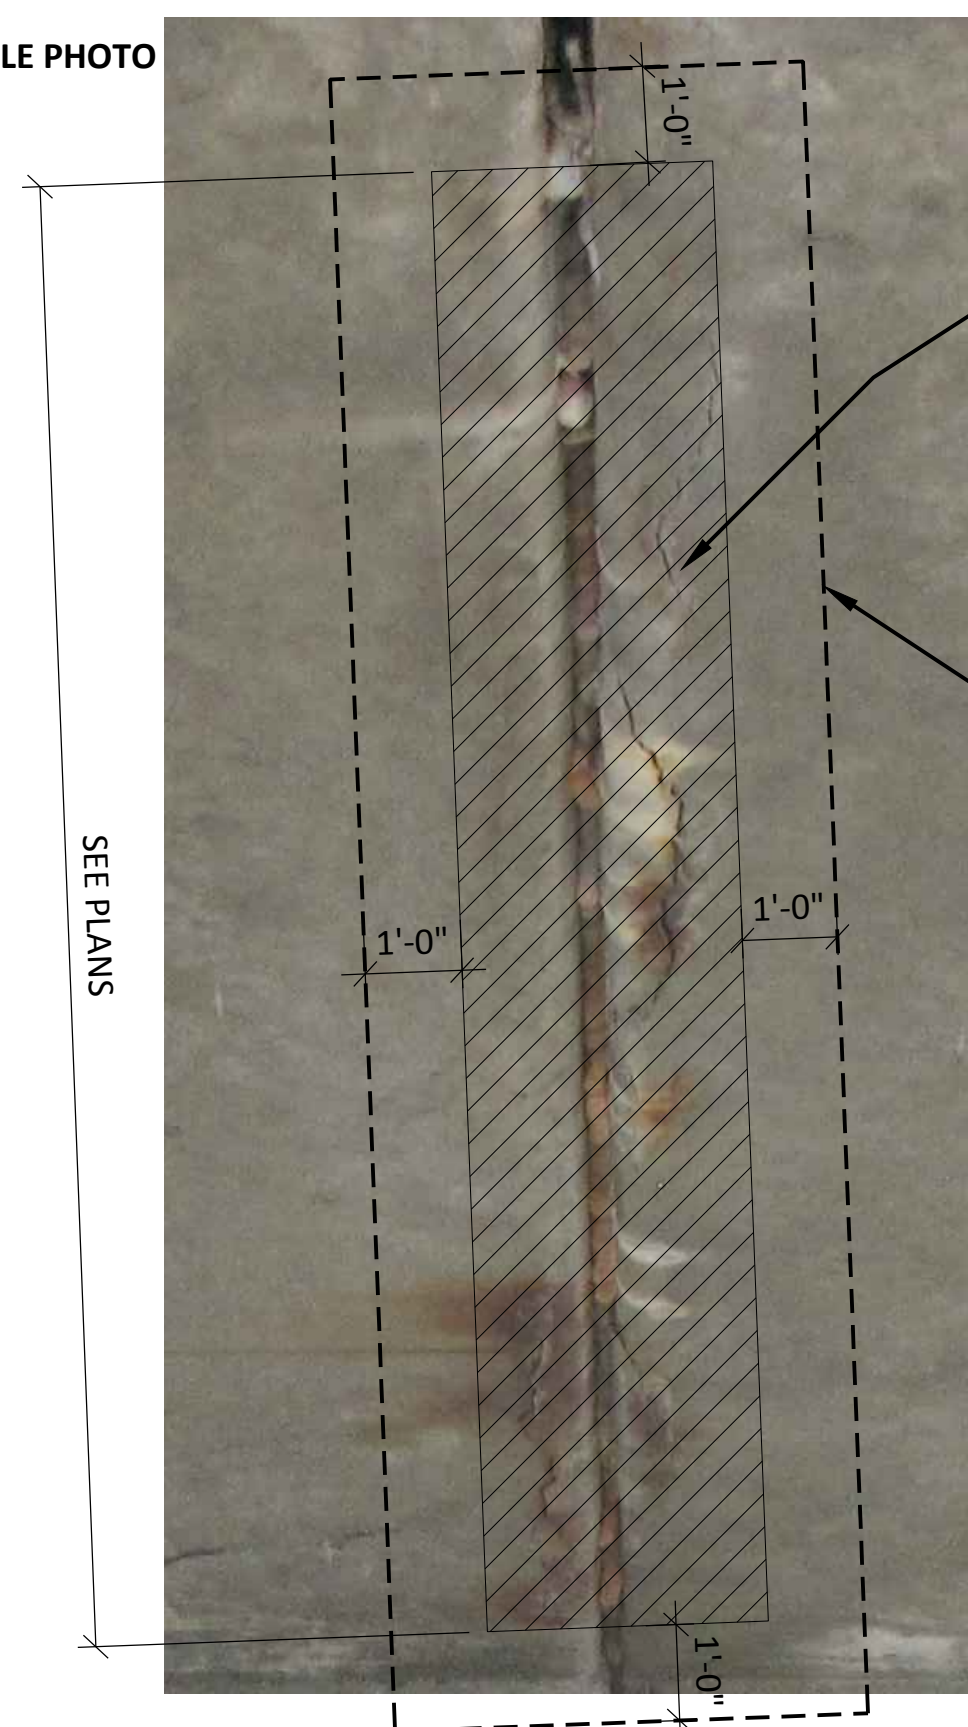
TEE CRACKING AT DECK JOINT
DECK JOINT REPAIR D2
S9

SURFACE DAMAGED CONCRETE AREA W/ HAIR LINE CRACKS

12" MIN BEYOND VISIBLE SIGNS OF CORROSION. REFER TO CLEAN AND COAT NOTES IN SECTION 10.02 OF THE SPECIAL PROVISIONS IN THE SPECIFICATIONS

NOTE:
THIS REPAIR ASSUMES THAT THE CONCRETE IS SOUND, IF NOT NOTIFY ENGINEER.

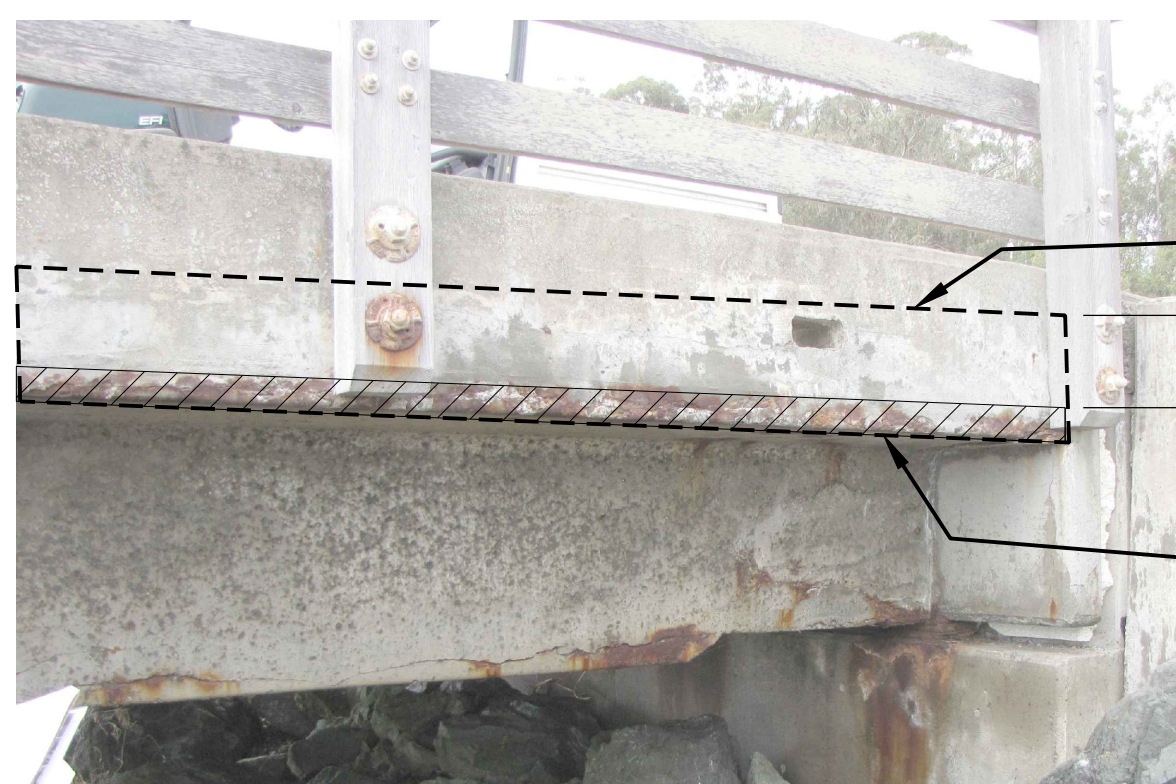
CORROSION AT EDGE OF TEE
CURB REPAIR C2
S9

DAMAGE CONCRETE AREA

CONCRETE REPAIR AREA. REFER TO CRACKING/ SPALLING REPAIR NOTES IN SECTION 10.02 OF THE SPECIAL PROVISIONS IN THE SPECIFICATIONS
