**Eagle Rim Trail Feasibility Assessment**  
**Mount Burdell Preserve**  
**Marin County Open Space District**

Prepared by:  
Marin County Parks  
Open Space Roads & Trails Division  
November 6, 2017

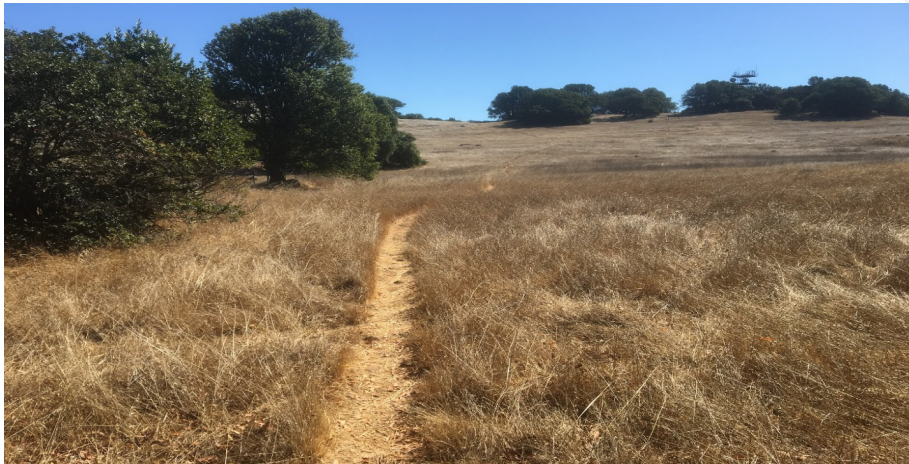
Photo 1: Upper Ridge Trail

The top 1,500 linear feet of the trail has an overall average grade of 5.94 percent, as it traverses along the ridge of Mt. Burdell. The area is composed primarily of grassland with sparse groupings of oak and bay trees. Currently there are two trailheads, which converge roughly 970 linear feet down the trail, Upper Ridge Trail 1 and Upper Ridge Trail 2, which are described below.

- Upper Ridge Trail 1 (URT1) is the beginning 970 linear feet of the Upper Ridge segment. The trail head diverges from Mt. Burdell Fire Road, 220 feet before the towers, and swings around them to the north through a shallow grass swale continuing down the fall line. URT1 has an average grade of 7 percent, with max grades up to 14 percent. Sight lines are very good. It currently has no dewatering features.
- Upper Ridge Trail 2 (URT2) is a 670-linear foot social trail that begins directly behind the towers and has an average grade of 13.4 percent. URT2 has an immediate 20 percent fall line grade for 250 feet, which is rutted with no potential to dewater the existing alignment. The trail then transitions to a consistent 10-15 percent grade for 420 feet, still following the fall line, with no opportunity to dewater.

The MCOSD recommends adopting the URT1 alignment. MCOSD recognizes the Towers to be an attractive eye nuisance, but anticipates by having the trail diverge prior would encourage users to stay out of the area. Both alignments have segments, which follow fall lines making dewatering difficult. URT1 does provide more opportunities for dewatering, however, and has an overall lower gradient. To mitigate the existing ruts MCOSD would fill and crown with amended native soil and base rock mix to encourage durability and longevity. The MCOSD would also install dewatering dips at regular intervals not to exceed 150' spacing.

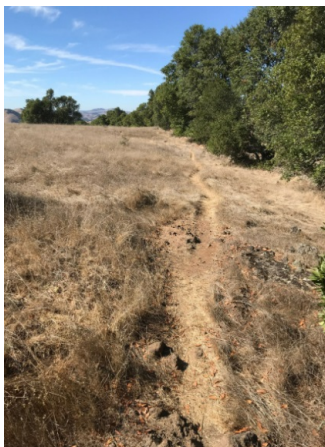
Photo 2: Existing Middle Ridge Trail

This 1,600 linear feet of trail has an average grade of 8.25 percent. The trail continues to meander along the ridge and northern property line. It has no built dewatering features though a few natural grade brakes do exist. The segment shows little evidence of erosion, even though it runs down the fall lines in places. Overall this segment is in good condition, and has very good sight lines (See Photo 2).

MCOSD would primarily adopt this segment in place. The MCOSD recommends the installation of dewatering, reverse grade dips, at 60-100' intervals, dependent on feasibility, soil stability, and grade. Minor realignments within the existing trail corridor, to pull the trail out of natural low areas, would be made to provide dewatering fall-lines. Import of amended native soil and base rock mix would be used, to fill ruts and create dewatering devices. Trees would be pruned to help increase sightlines where needed.

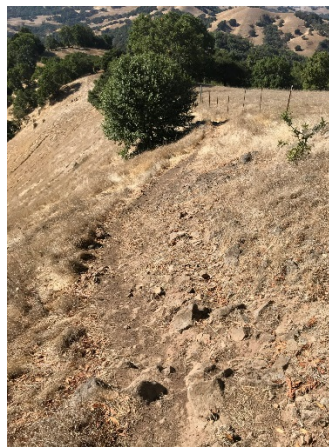
Photo 3: Existing Lower Ridge Trail

The final 750 linear feet of the ridgeline segment, has an average grade of 20.4 percent, before the climbing turn down through the lower bowl. This portion of trail is highlighted by short segments of steep grades with rock steps and rock outcrops. The trail being predominately on bedrock is very stable given its grade. Overall this segment is in good condition and has very good sight lines. The side slope off, of the ridgeline alignment has grades of 50-75 percent, making any reroutes unfavorable (See Photo 3).

Adopt the alignment in place improving upon and installing dewatering features where feasible. The existing rock outcrops currently serve well as natural dewatering areas. Rock steps and rock grading would be incorporated to improve safety where appropriate. Trees would be pruned to improve sight lines.

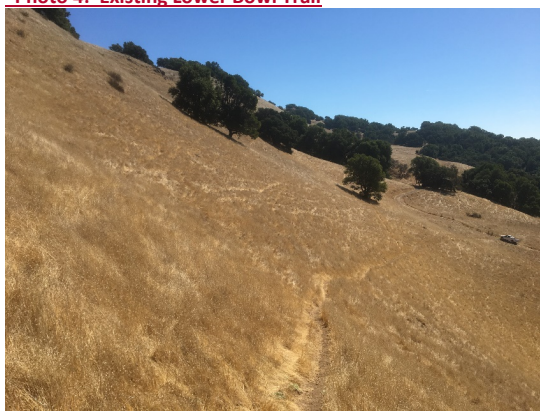
**Photo 4: Existing Lower Bowl Trail**

The final segment consists of 675 linear feet of narrow trail traverses through grassy bowl which terminates with the Deer Camp Fire Road. The current trail travels along a steep side slope, that has a shallow soil layer before bed rock. The trail sightlines are excellent, as you can see through the entire grassland segment. The existing alignment has an average grade of 18.4 percent with sections up to 26 percent, which does not show evidence of erosion or rutting on the alignment (See Photo 4).

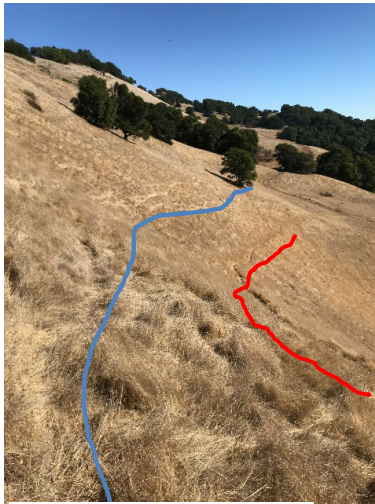
Photo: 38+60 - 48+15

Upon field observation and review of USDA soil surveys, the area of the Lower Bowl trail realignment is composed of a relatively stable and rocky composition, providing an overall durable tread. The current 675 foot trail alignment has an average grade of 18.4 percent, with a maximum grade of 26 percent.

The proposed new alignment, would provide the ability to maintain a sustainable tread, reduce steep grades, maintain good sightlines, and improve passing zones. The rerouted alignment is 955 feet in length at a 10 percent average trail grade. Due to the steep cross slope, the trail would be approximately 30 inches wide, except at designated bulb outs on the trail. Dewatering reverse grade dips and knicks would be incorporated into the new alignment at 100' maximum intervals to ensure stability and longevity.
