MARIN COUNTY PARKS

MCNEARS BEACH PARK

PIER REPAIR

ISSUED FOR CONSTRUCTION

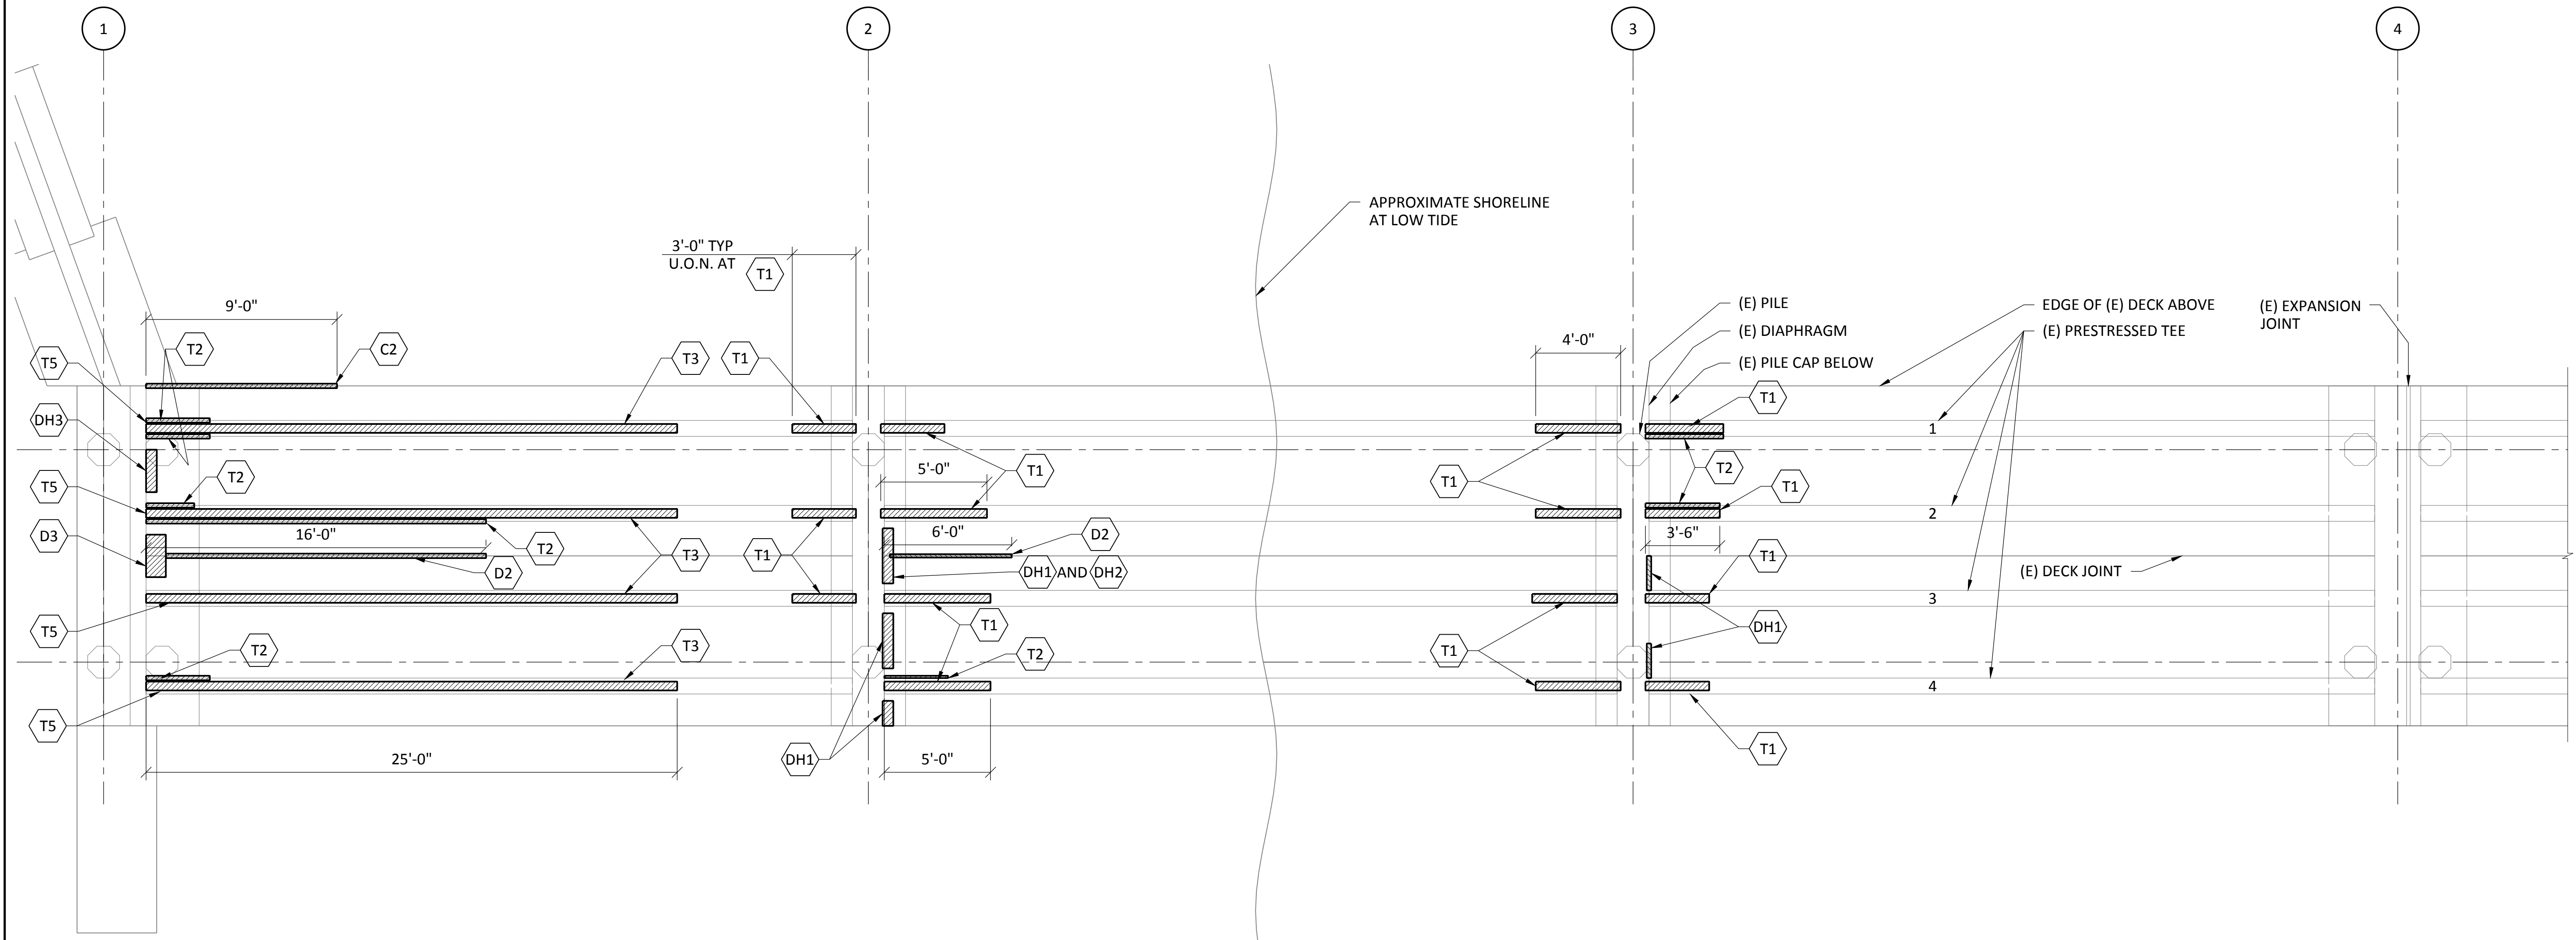
PIER REPAIR PLAN
 1/4" = 1'-0" 1 / S2

| T1 TEE SPALLING/ CRACKING , SEE DETAIL T1/S5 | DH2 DIAPHRAGM CRACKING, SEE DETAIL DH2/S8 |
| T2 TEE WEB SPALLING, SEE DETAILS T2/S5 | DH3 DIAPHRAGM CRACKING AT SPAN 1, SEE DETAIL DH3/S8 |
| T3 TEE CRACKING AT MID SPAN, SEE DETAIL T3/S6 | DH4 DIAPHRAGM CRACKING, SEE DETAIL DH4/S8 |
| T4 LOCALIZED TEE WEB SPALLING, SEE DETAIL T4/S6 | D1 TEE CORROSION AT DECK TIE, SEE DETAIL D1/S9 |
| T5 TEE SPALLING AT SPAN 1, SEE DETAIL T5/S7 | D2 TEE CRACKING AT DECK JOINT, SEE DETAIL D2/S9 |
| T6 TEE WEB SPALLING AT EXPANSION JOINT, SEE DETAIL T6/S7 | D3 TEE CORROSION AT DECK JOINT, SEE DETAIL D3/S9 |
| DH1 SPALLING AT BOTTOM OF DECK, SEE DETAIL DH1/S8 | C1 SPALLING AND CORROSION AT CURB DRAIN HOLES, SEE DETAIL C1/S9 |

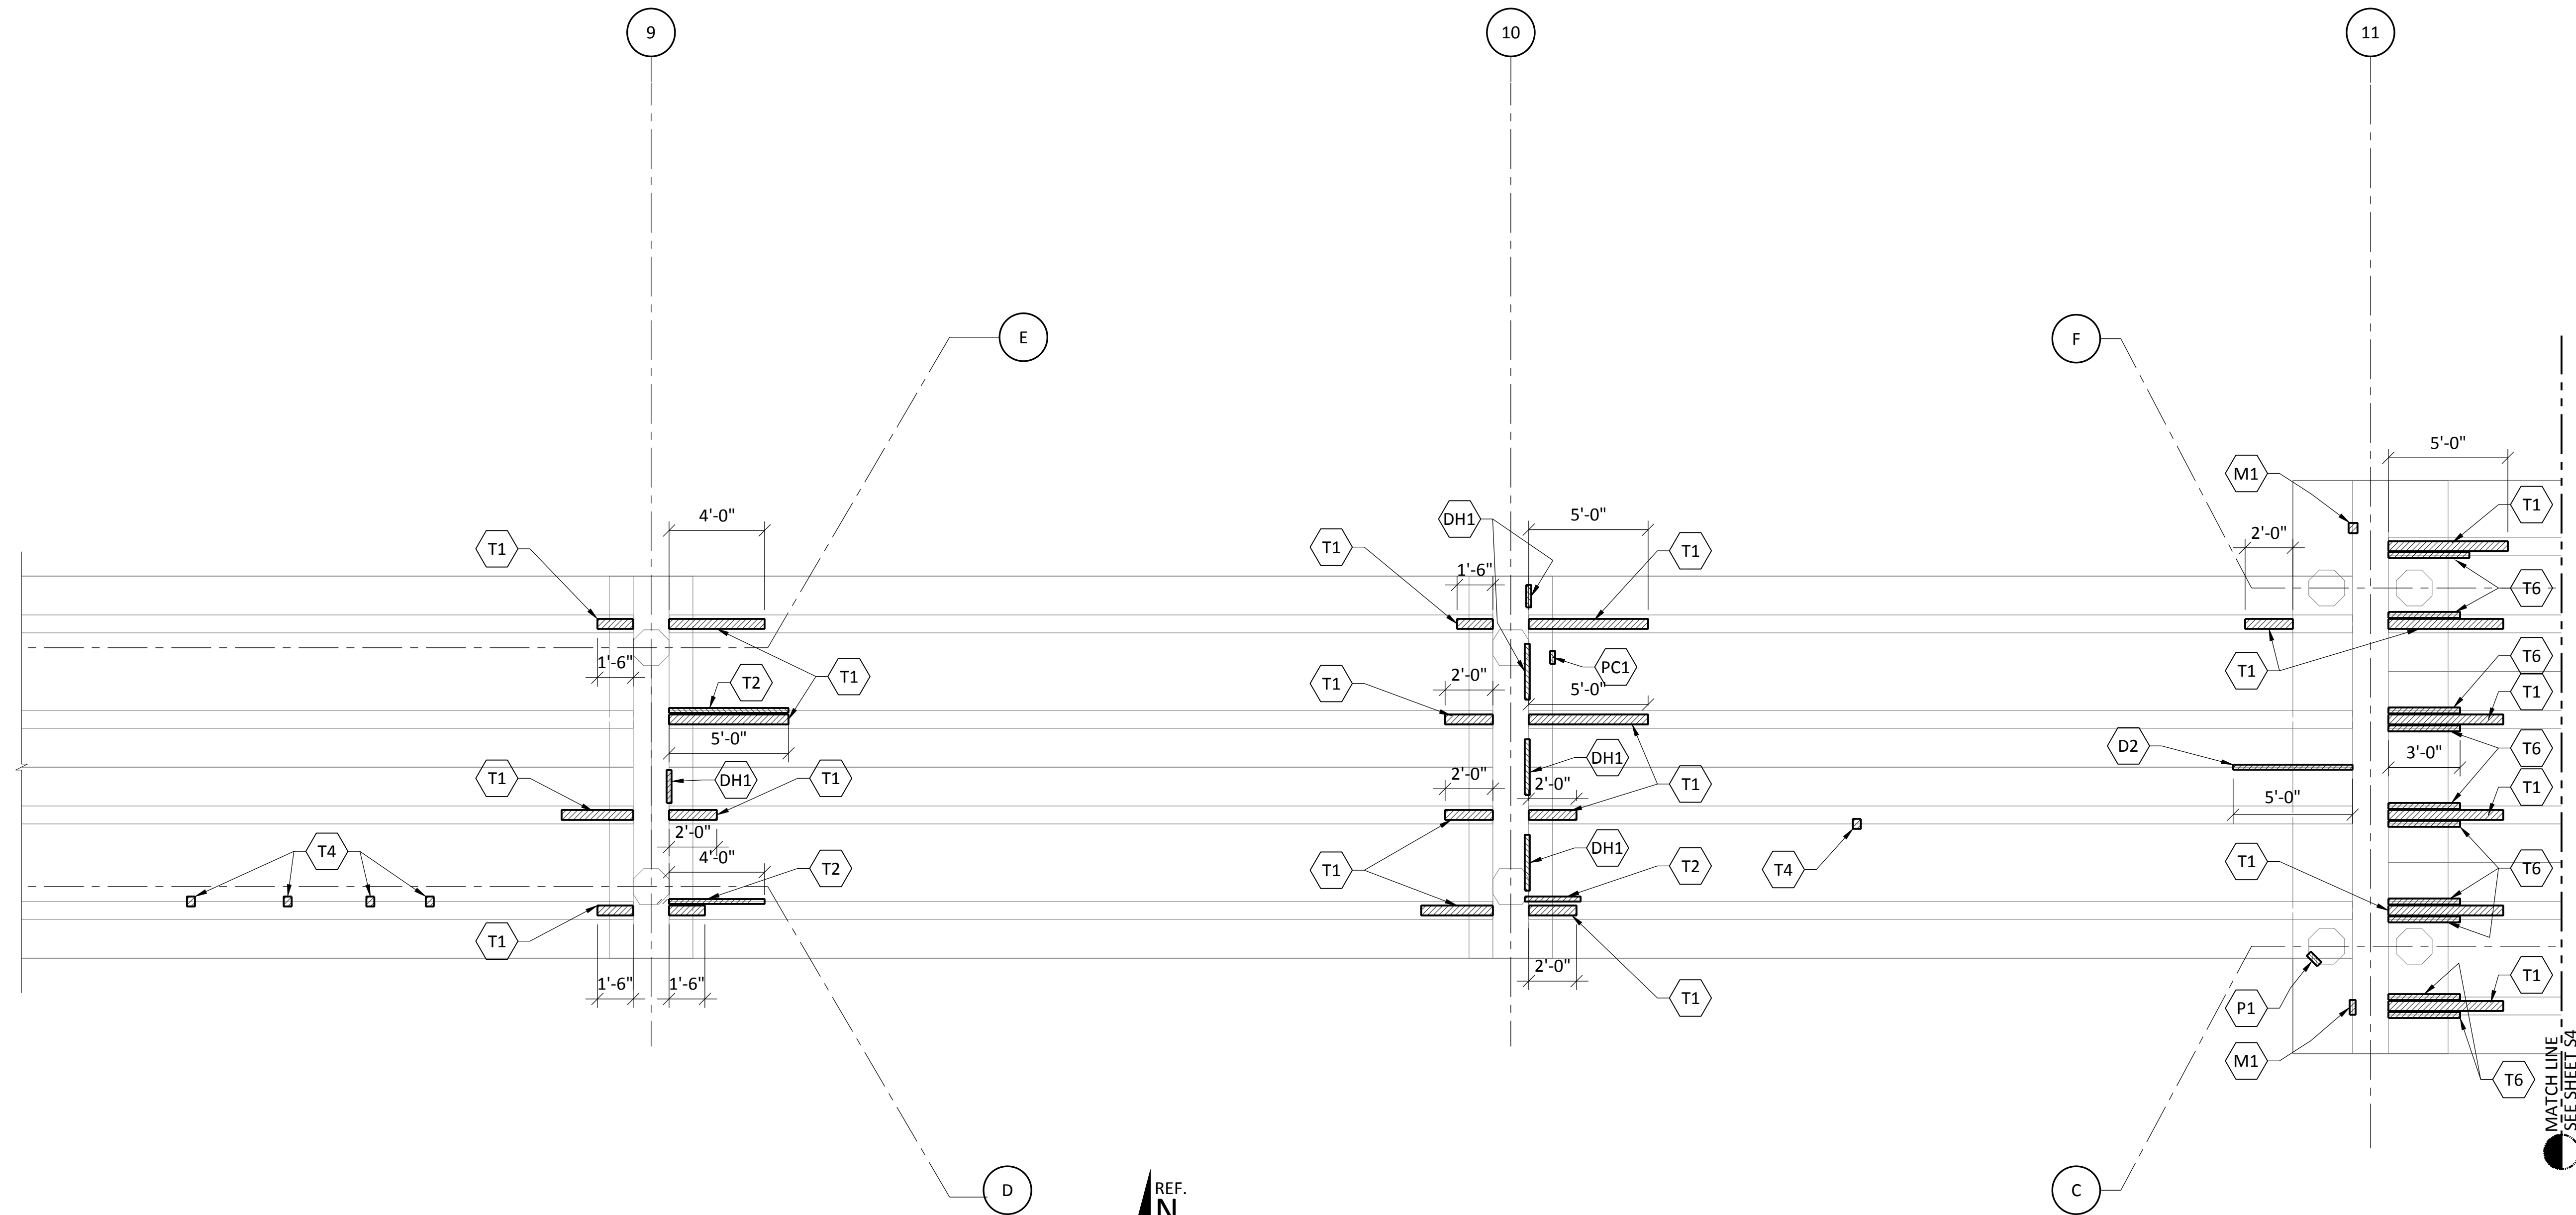
| T1 | TEE SPALLING/ CRACKING , SEE DETAIL T1/S5 | DH2 | DIAPHRAGM CRACKING, SEE DETAIL DH2/S8 |
| T2 | TEE WEB SPALLING, SEE DETAILS T2/S5 | DH3 | DIAPHRAGM CRACKING AT SPAN 1, SEE DETAIL DH3/S8 |
| T3 | TEE CRACKING AT MID SPAN, SEE DETAIL T3/S6 | DH4 | DIAPHRAGM CRACKING, SEE DETAIL DH4/S8 |
| T4 | LOCALIZED TEE WEB SPALLING, SEE DETAIL T4/S6 | D1 | TEE CORROSION AT DECK TIE, SEE DETAIL D1/S9 |
| T5 | TEE SPALLING AT SPAN 1, SEE DETAIL T5/S7 | D2 | TEE CRACKING AT DECK JOINT, SEE DETAIL D2/S9 |
| T6 | TEE WEB SPALLING AT EXPANSION JOINT, SEE DETAIL T6/S7 | D3 | TEE CORROSION AT DECK JOINT, SEE DETAIL D3/S9 |
| DH1 | SPALLING AT BOTTOM OF DECK, SEE DETAIL DH1/S8 | C1 | SPALLING AND CORROSION AT CURB DRAIN HOLES, SEE DETAIL C1/S9 |

| C2 | CORROSION AT EDGE OF TEE, SEE C2/S9 |
| M1 | HARDWARE CORROSION, SEE DETAIL M1/S9 |
| P1 | SPALLING AT TOP OF PILE, SEE DETAIL P1/S10 |
| PC1 | CORROSION ON PILE CAP, SEE DETAIL PC1/S10 |

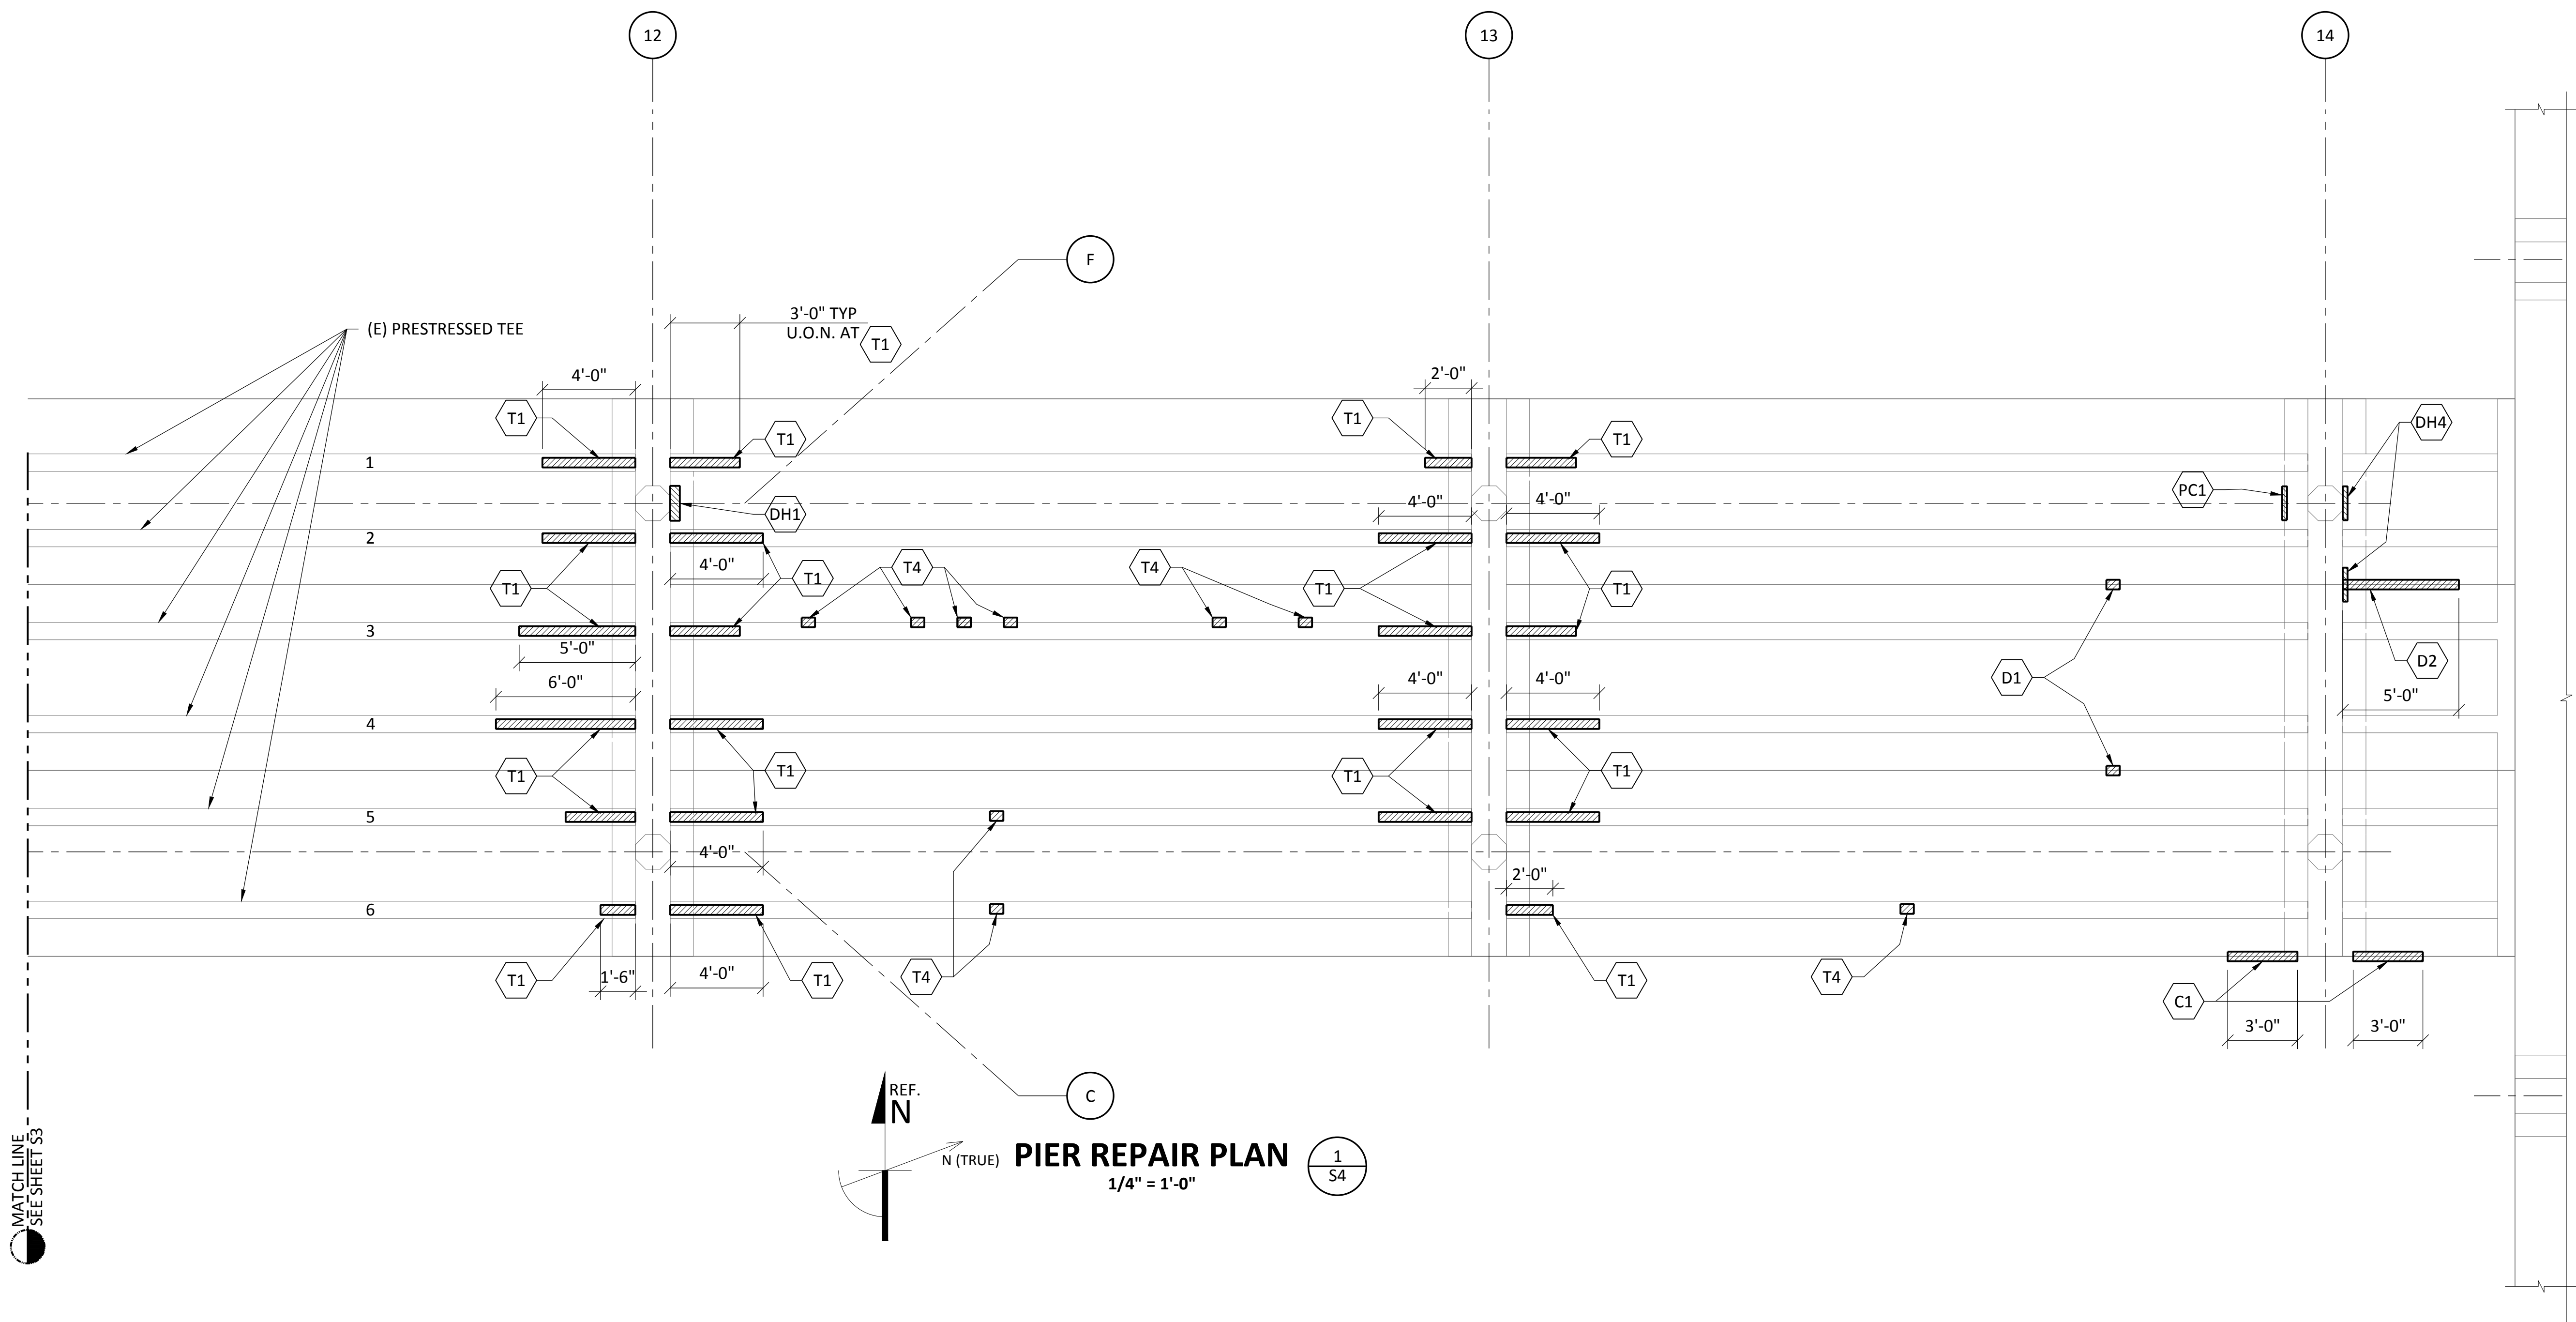
REF. N
 N (TRUE)
PIER REPAIR PLAN
 1/4" = 1'-0"
 1/S4

| T1 | TEE SPALLING/ CRACKING , SEE DETAIL T1/S5 | DH2 | DIAPHRAGM CRACKING, SEE DETAIL DH2/S8 |
| T2 | TEE WEB SPALLING, SEE DETAILS T2/S5 | DH3 | DIAPHRAGM CRACKING AT SPAN 1, SEE DETAIL DH3/S8 |
| T3 | TEE CRACKING AT MID SPAN, SEE DETAIL T3/S6 | DH4 | DIAPHRAGM CRACKING, SEE DETAIL DH4/S8 |
| T4 | LOCALIZED TEE WEB SPALLING, SEE DETAIL T4/S6 | D1 | TEE CORROSION AT DECK TIE, SEE DETAIL D1/S9 |
| T5 | TEE SPALLING AT SPAN 1, SEE DETAIL T5/S7 | D2 | TEE CRACKING AT DECK JOINT, SEE DETAIL D2/S9 |
| T6 | TEE WEB SPALLING AT EXPANSION JOINT, SEE DETAIL T6/S7 | D3 | TEE CORROSION AT DECK JOINT, SEE DETAIL D3/S9 |
| DH1 | SPALLING AT BOTTOM OF DECK, SEE DETAIL DH1/S8 | C1 | SPALLING AND CORROSION AT CURB DRAIN HOLES, SEE DETAIL C1/S9 |

| C2 | CORROSION AT EDGE OF TEE, SEE C2/S9 |
| M1 | HARDWARE CORROSION, SEE DETAIL M1/S9 |
| P1 | SPALLING AT TOP OF PILE, SEE DETAIL P1/S10 |
| PC1 | CORROSION ON PILE CAP, SEE DETAIL PC1/S10 |

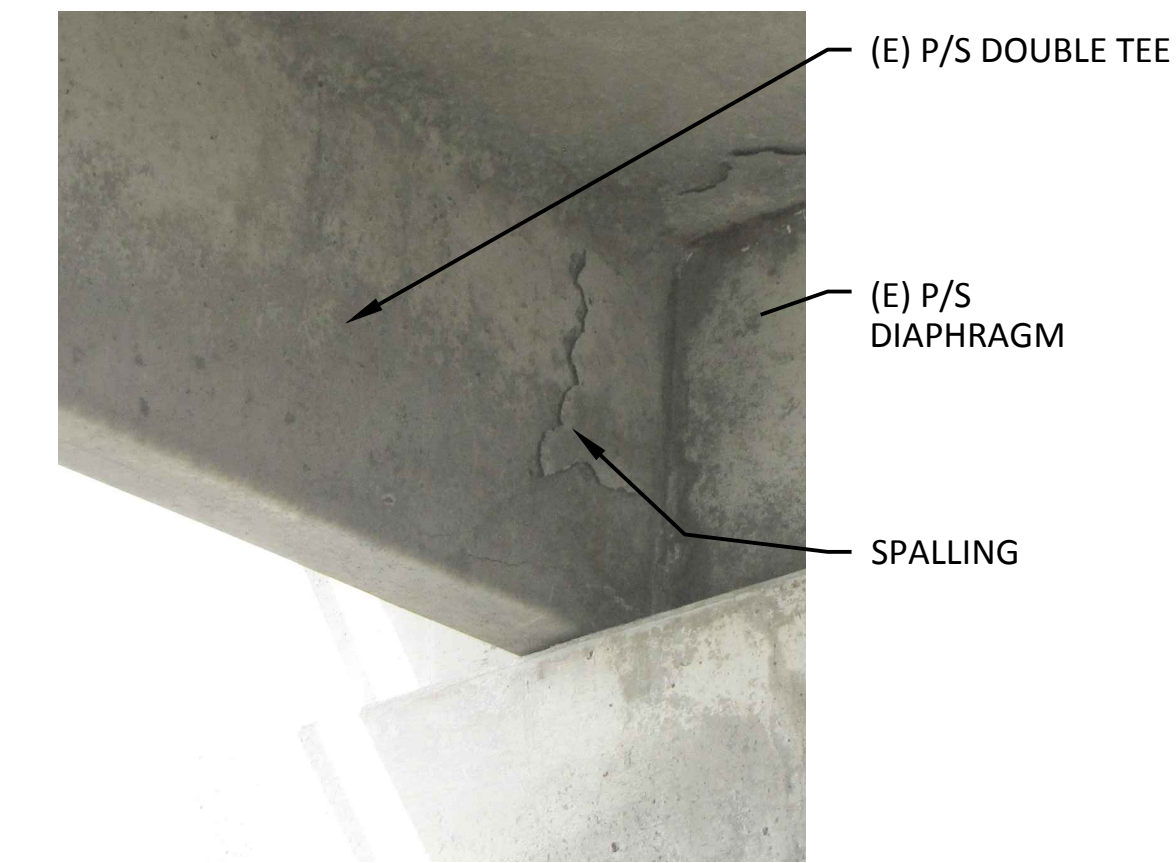
TEE REPAIR T1
1" = 1'-0"

TEE CRACKING AT BOTTOM NEAR PILE CAP

TEE SPALLING AT BOTTOM NEAR AT PILE CAP

TEE WEB SPALLING NEAR PILE CAP

NOTE:
DAMAGE VARIES
COULD EXTEND TO
FULL DEPTH OF WEB

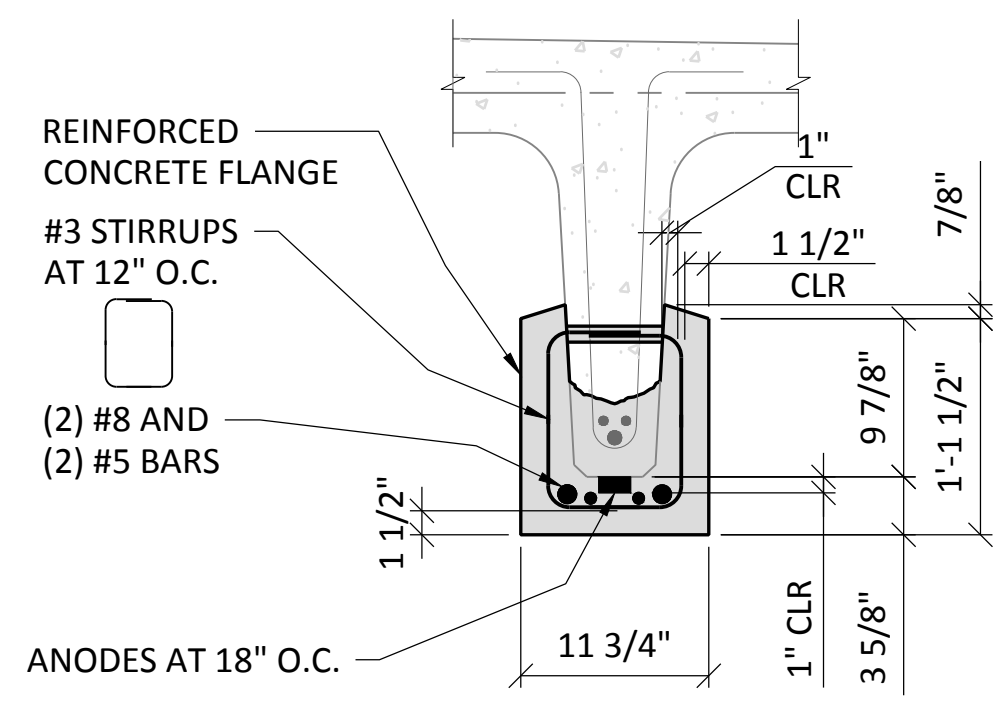
SECTION A
 1" = 1'-0" A S6

TEE CRACKING AT SPAN 1

- NOTES:
1. FOR ADDITIONAL REPAIRS AT EAST END SEE SHEET S5.
 2. FOR ADDITIONAL REPAIRS AT WEST END SEE SHEET S7.
 3. DO NOT DAMAGE PRESTRESSED STRANDS DURING CONSTRUCTION. FOR REPAIR NOTES, SEE SECTION 10.02 AND 10.13 OF THE SPECIAL PROVISIONS IN THE SPECIFICATIONS

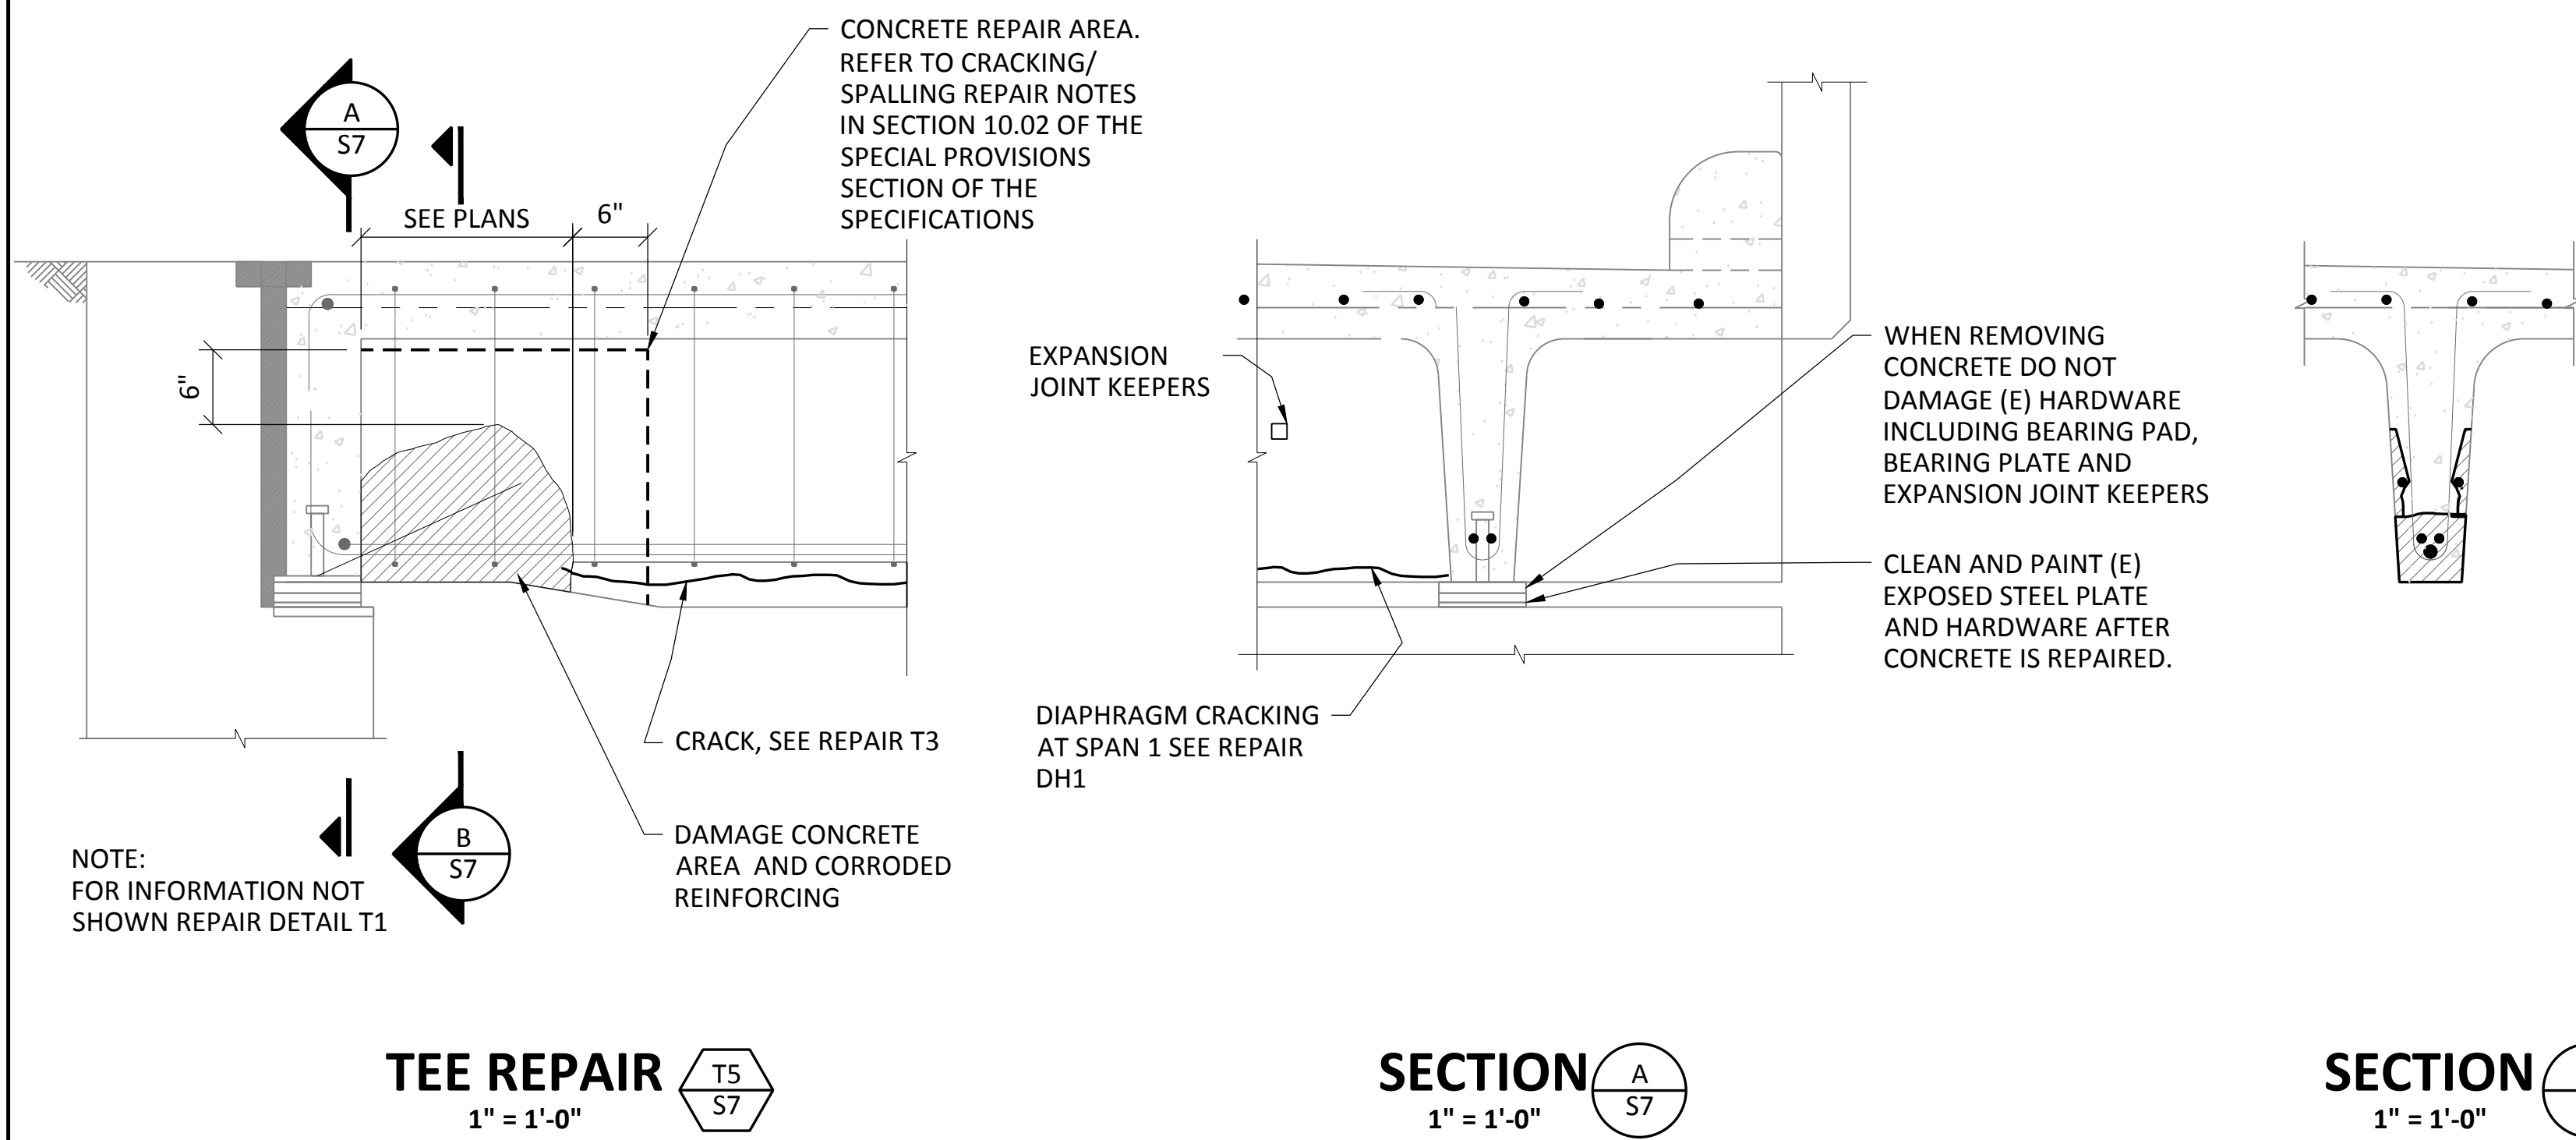
TEE SPALLING AT SPAN 1

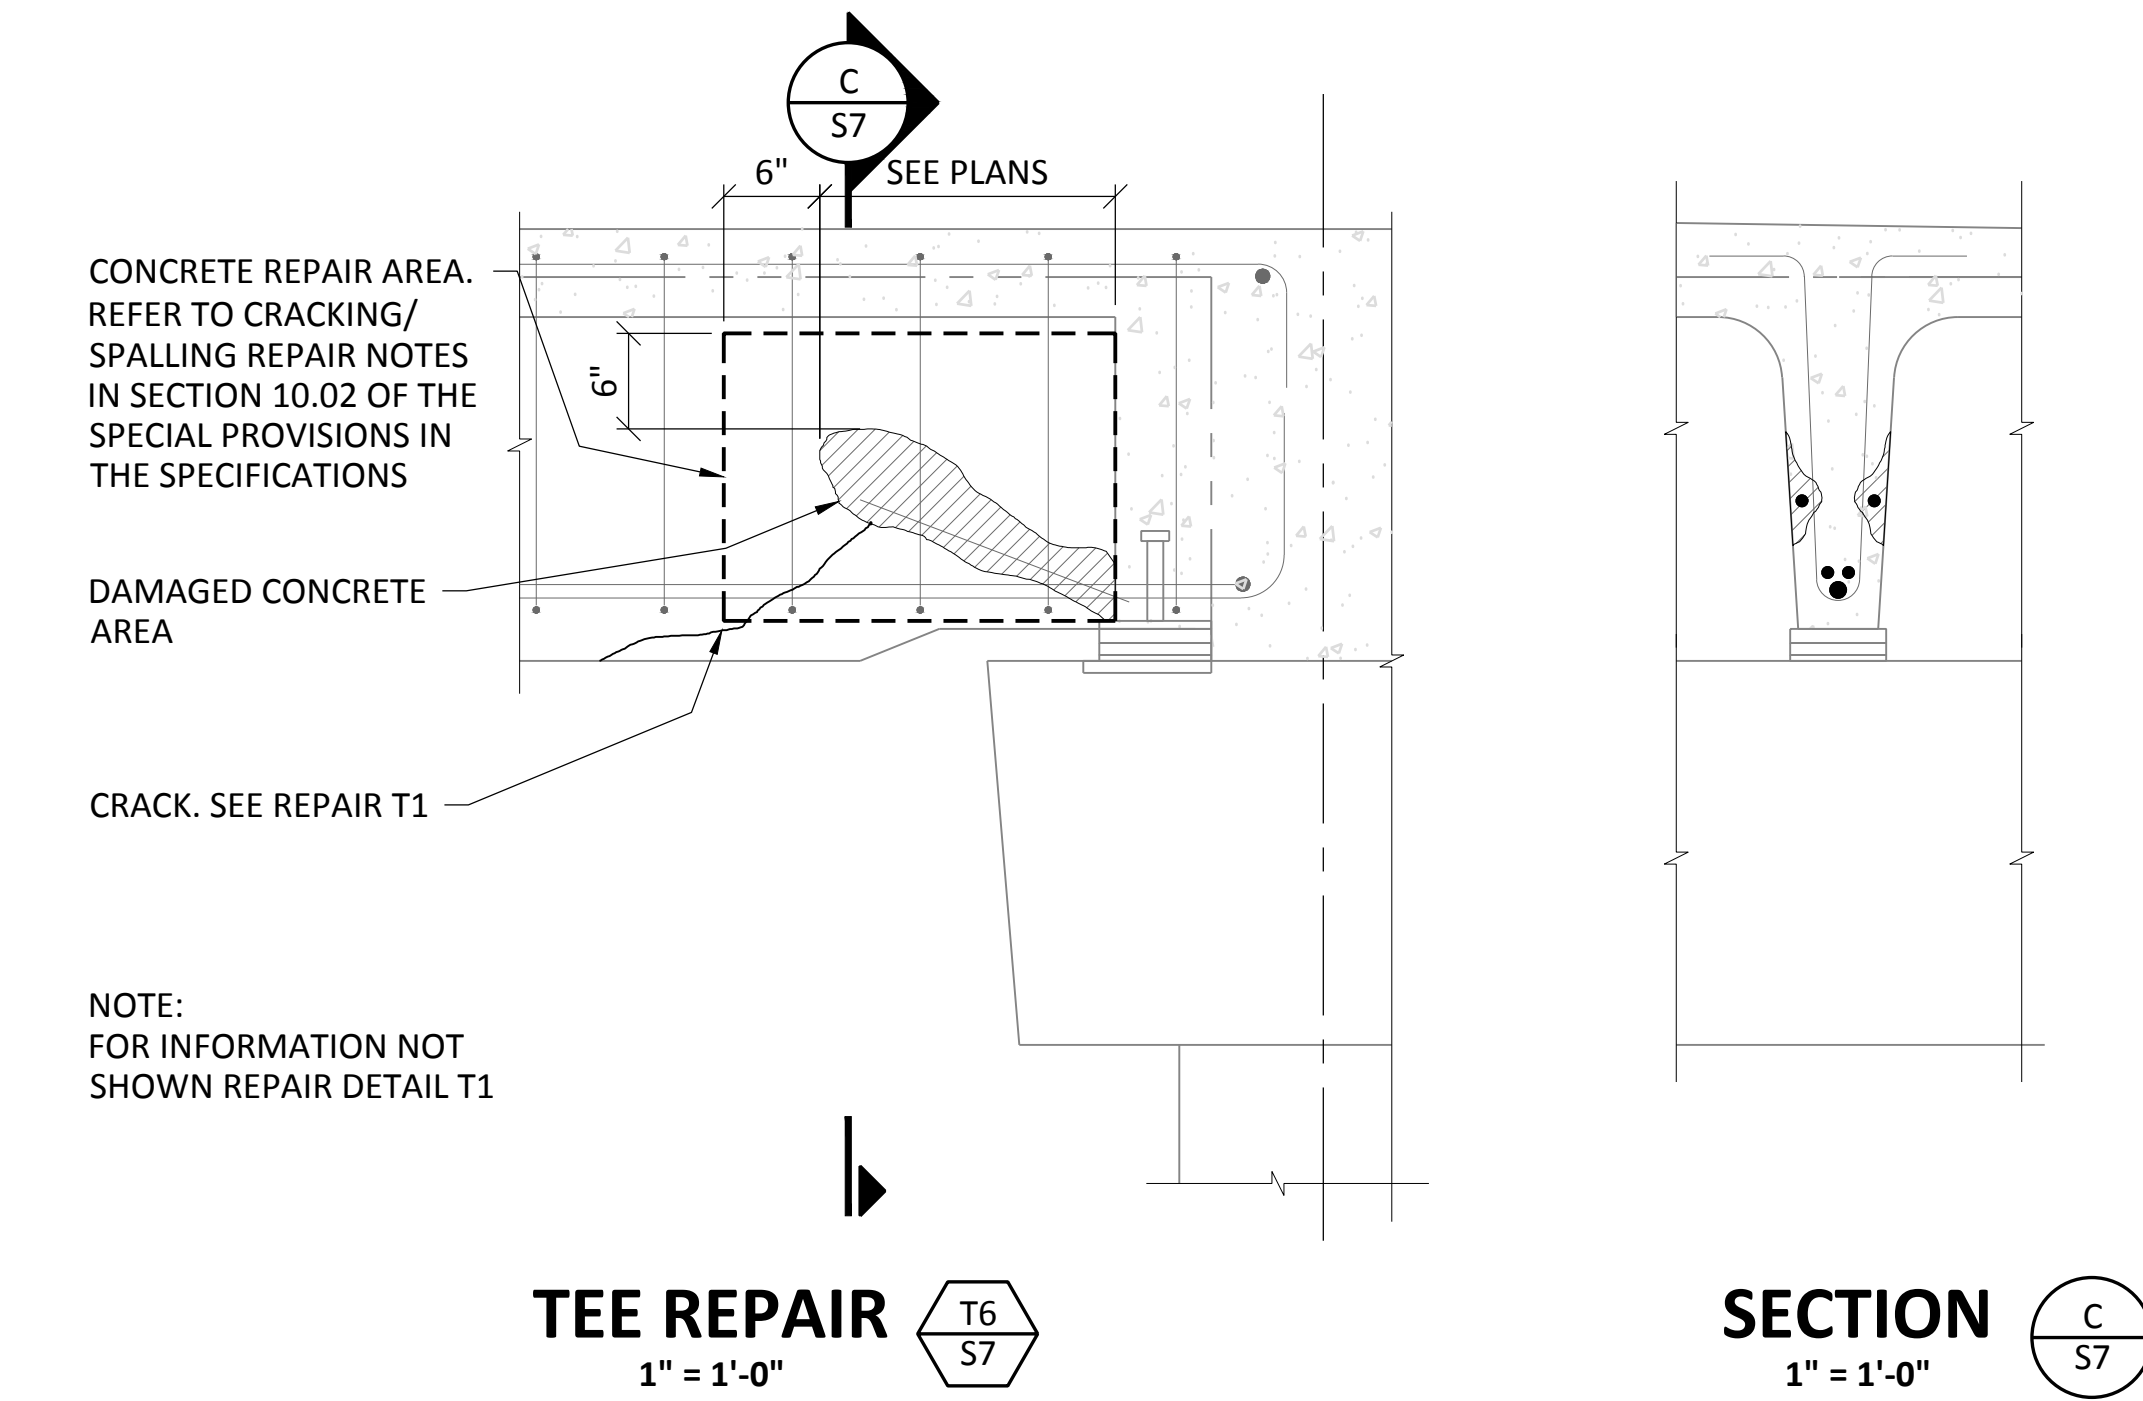
SPALLING AT EXPANSION JOINT HARDWARE
(E) P/S DOUBLE TEE
CRACK
(E) PILE CAP

CRACKING AT EXPANSION JOINT HARDWARE
(E) P/S DOUBLE T-BEAM
(E) PILE CAP

TEE WEB SPALLING AT EXPANSION JOINT HARDWARE

TEE WEB CORROSION AT EXPANSION JOINT HARDWARE
